Relations between static-structural aspects, construction phases and building materials of San Saturnino Basilica (Cagliari, Italy)

Stefano COLUMBU¹ | Antonio CAZZANI² | Alessandro RUGGIERI³

Proceedings of the 19th International Conference on Cultural Heritage and New Technologies 2014 (CHNT 19, 2014)

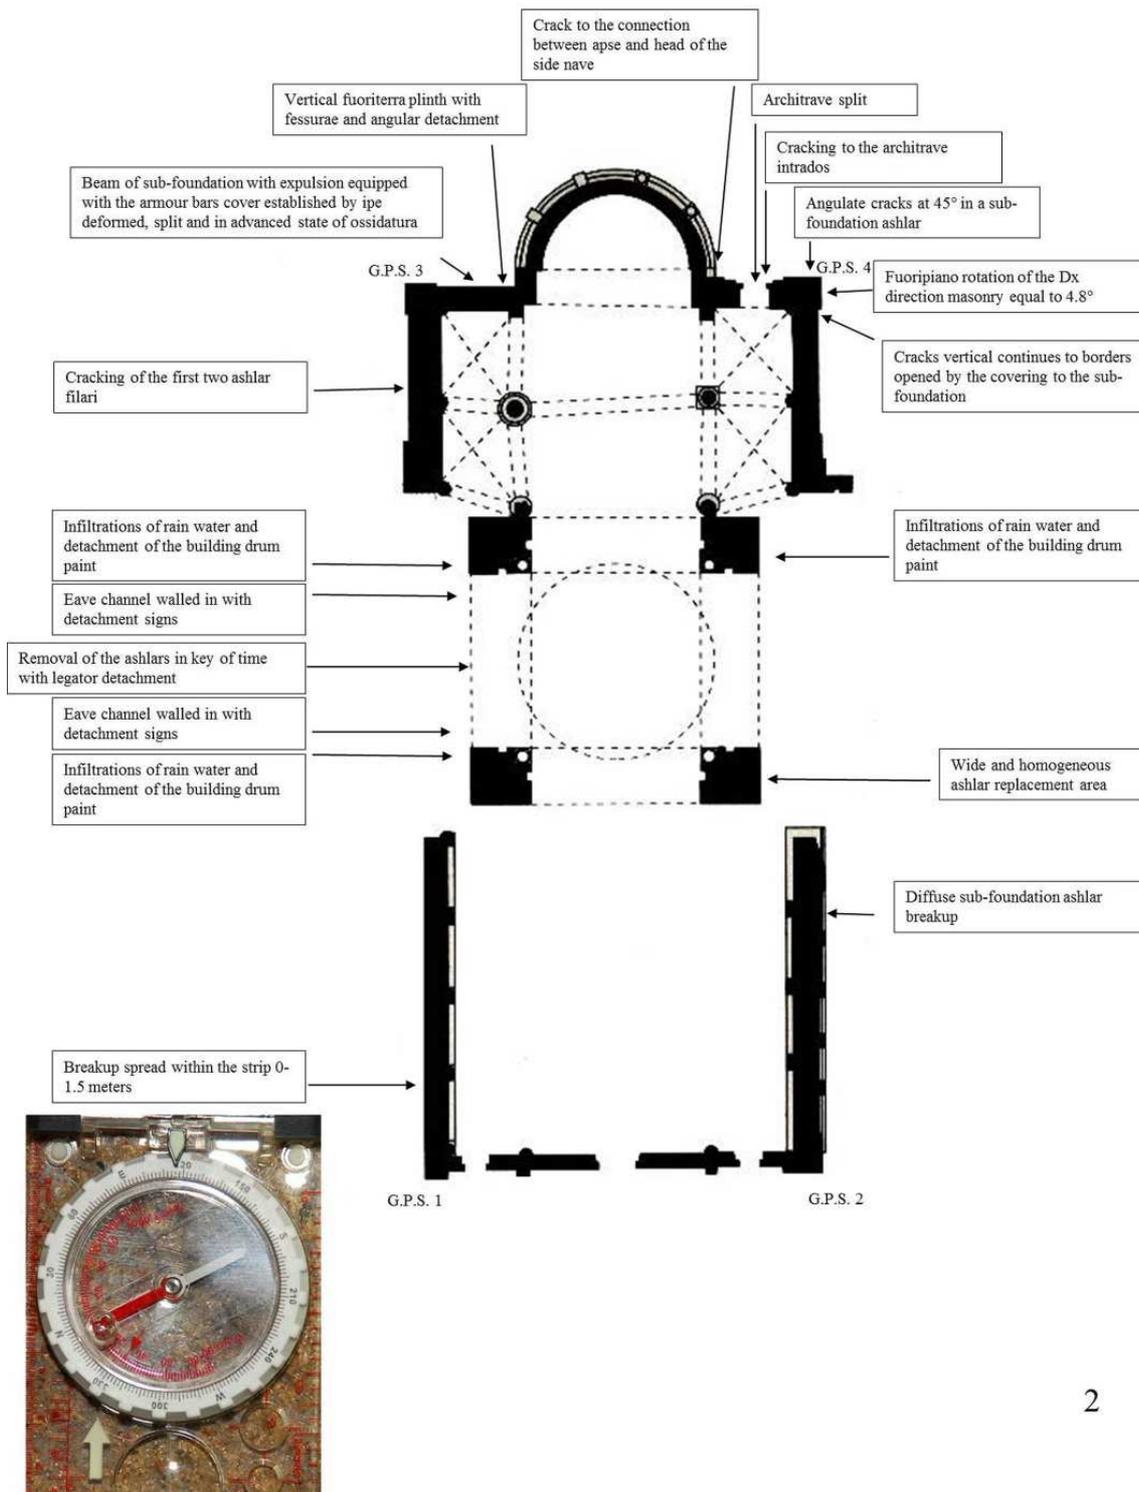
DEFECTOLOGICO OUTSIDE PICTURE

Areas affected by exhibitions of degradation due to structural damage: aisle facing south, aisle facing north, domed central structure (Figs. 3, 4, 5).

Fig. 4 – Defectology list of San Saturnino church; survey of the exterior of the building.

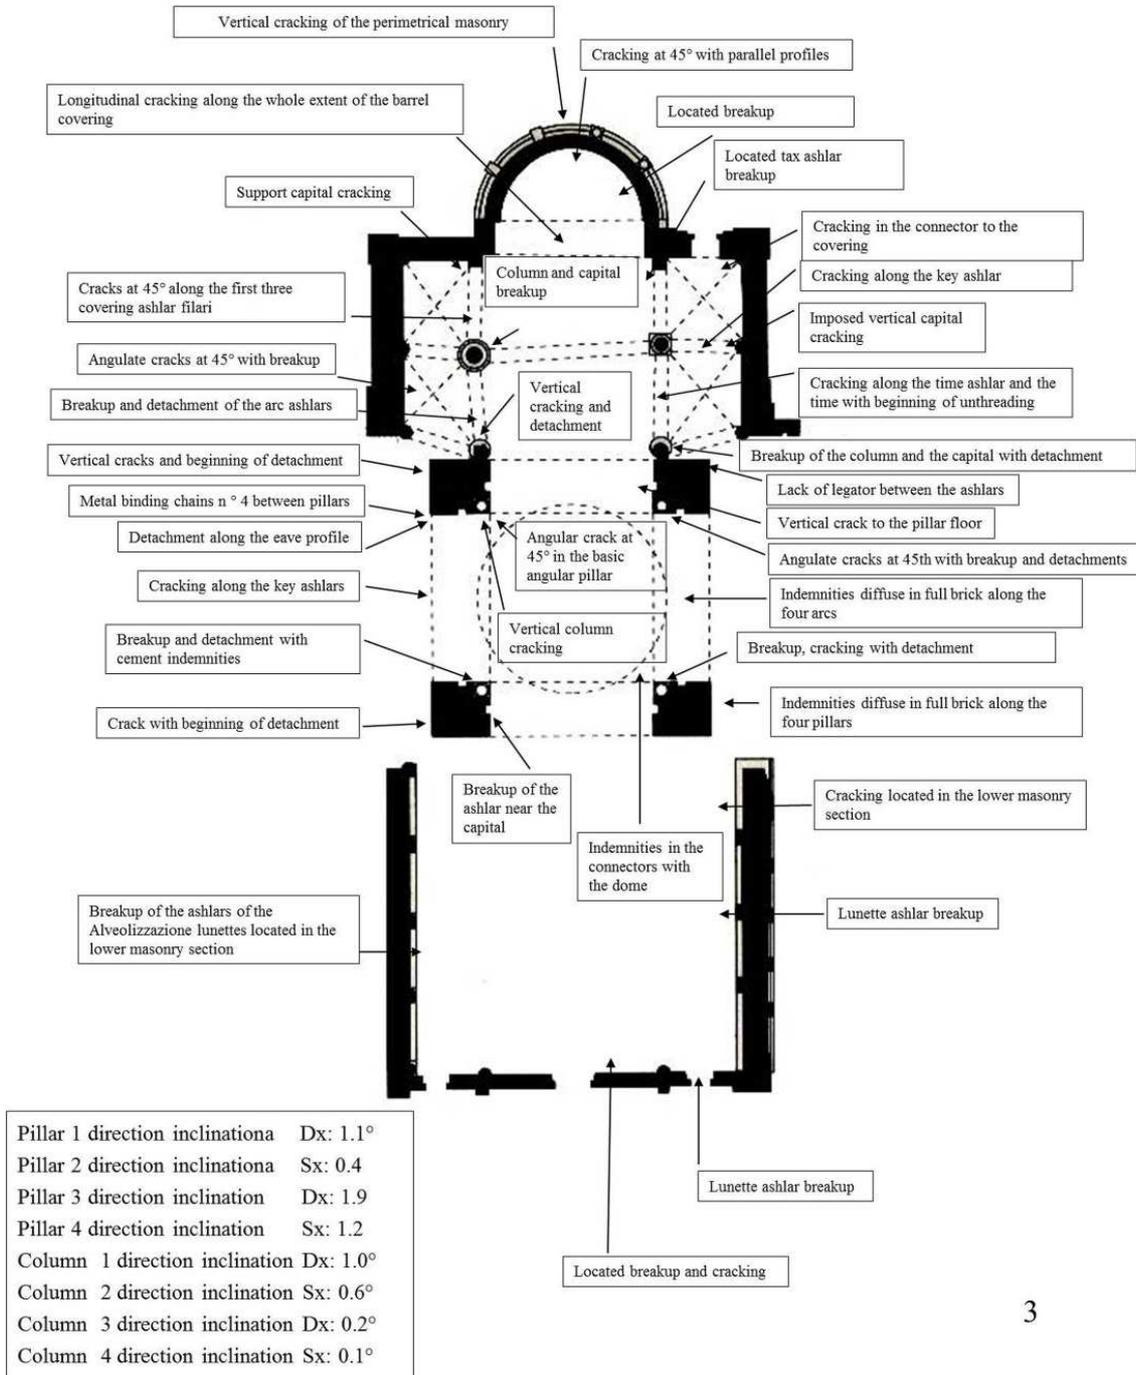
DEFECTOLOGICO INTERIOR PICTURE

The central domed structure exhibits, at present, no degenerative structural underway. However, it should read the current condition as the result of multiple restorations that have contributed to the current condition of substantial balance. Starting from the four pillars with alveolate columns the widespread presence of cracking with a beginning of vertical separation in the pillars marked with numbers 1, 3, 4 can be observed. Pillar number 3 does not have any signs of detachment while number 1 presents the basic slots angled at 45°. The arch that rests on pillars 1 and 3 shows the loss of the mortar in the vicinity of the dressed stone at a time and the subsequent extraction of the same end. This anomaly is evident both inside and outside the building. Slippage of the dressed stone at once suggests the presence of a tension zone, which produced the dismissal taking place between pillars 1 and 3. As an evidence of this condition, perhaps even spread to the pillars 2 and 4, there are four passive iron rods that bind among them the pillars. By inspection it is not possible to infer the condition of stress which they are subjected. Imaging studies would provide useful pieces of information about the actual work done.

In the dome, by visual inspection, no cracks were evident but this is the result of many restorations. In documentary sources dating back to the 50s numerous cracks are observed with a vertical trend and running along the beds of mortar determining the separation and subsequent extraction of the segments. In this sense, it is operated with infiltration of cement mortar and numerous localized damages. The dome in the 50s was reinforced with circular bars within the drum hoops, but in the 80s was close to failure due to horizontal thrust caused by its self-weight. The comparison between the condition of pillars, arches and dome indicate that there has been a kinematic collapse, which was effectively stopped by the positioning of

the tie rods located between the pillars and the hoops of the dome. Their effectiveness is deductible from the total lack of cracks in the dome concentric, dents or buckling. Further evidence of a safe condition comes from the almost total lack of off-the-lead of the pillars and alveolar columns (the values are given in the annex graph).

Fig. 5 – "defectology sketch" of San Saturnino church; the interior of the building pad.

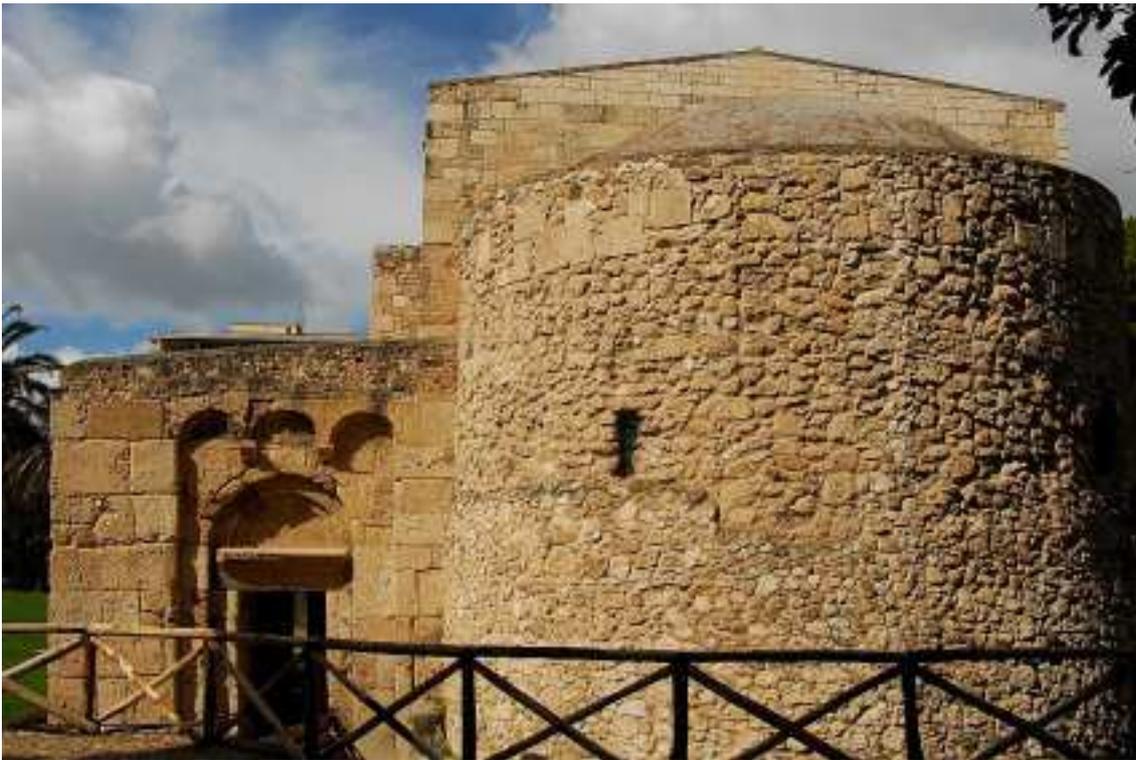
The analysis of cracks and generally the defectology list indicates a condition of damage caused by heterogeneous agents in a very long period of time. The focus is on two specific areas identified in the heads of the side aisles of the east-facing arm. The south-facing aisle (Figs. 6, 7) has a clear slope towards the outside of the structure. This condition is accompanied by the presence of numerous cracks originating from the node. The clamping between the apse and the masonry of the head of the aisle and continuing downwards with vertical and diagonal trends from the roof of the nave (Fig. 8) up to reoccur in the blocks of the foundation where it assumes a diagonal trend with open external flaps. When crossing the wall of the cylinder head the crack involves the element lintel which is cracked both at the intrados and at the extrados. The north-facing aisle, as mentioned, is the result of the reconstruction which took place after the bombings of World War II (Fig. 9). However it should be noticed the structural damage whose condition might short endanger the structural safety of the aisle. The head of the nave rests on a reinforced concrete beam which has as support points two small plinths made for two thirds above-ground (Fig. 10). The girder was reinforced with a single profiled type IPE steel beam and presents the almost total expulsion of the concrete cover (Fig. 11). The same IPE beam is oxidized with obvious exfoliation and detachment of plaques. The reduction of the resistant section represented by the web has caused the deformation of the web itself by crushing. The plinth support, placed below the perimeter wall, presents a deep vertical slot with a beginning of angular detachment which can be due to a strong compression action, together with the likely carbonation of reinforcing rods.

Fig. 6 – Prospectus apse, particularly the apse and the head of the Aisle facing South.

With reference to the aisle facing south, the detected elements provide a circumstantial framework, which is homogeneous and convergent, corresponding to the occurrence of a kinematic localized collapse. It produced an off-plane rotation of the south-facing masonry. Along the first row of vines a cylindrical hinge takes place that leads to the rotation, not only of the perimeter wall facing south, but because of the effectiveness of the node this angular displacement involves also the masonry head facing east, which, finding in the structural node represented by scarfing the nave an effective constraint, produces the elevation of the entire head of the aisle in what is called a rollover-type complex. Further evidence of the onset of a kinematic collapse is found in the shell from the same aisle with the cracking of ashlar junction between the vault and the perimeter wall. Cracking of some blocks and extraction of the same can be clearly observed. Vertical cracks resulting from compression of the capitals sets and localized detachment from eccentric compression in a column are also seen. Detachment and loss of the mortar between blocks caused the dismissal. The most obvious cause of this condition is identifiable in a yielding backdrop that involves the entire south side of the nave and the front thereof. The failure was caused by the excavation perimeter, which runs along the entire perimeter of the structure. Archaeological research at the site resulted in a lowering of the share of foot traffic outside in some places which exceeds two meters below level zero. Moreover, this excavation was performed arriving close to the perimeter walls, virtually eliminating the counterforce that these exerted against the perimeter walls. The situation is also complicated by the nature of the walls that have been made with the technique and reveal a lot more points diatonos shortages and the lack of homogeneity of the materials used in the cavity. In these conditions, and in the absence of elements of confinement, the dividing wall outside deviates from the septum of ceiling. Such removal in the absence of viscosity can lead to the collapse of the only external face, but often this involves the hanging ceiling which

has not a sufficient mass and yields to an horizontal thrust. Indeed, the resulting vector determined by the weight acting vertically and the thrust vector acting horizontally produce a force oriented at 45° right in the direction followed by the walls at the time of the collapse. Among the factors that have worsened the situation there were the constant changes in the groundwater level and the history of the building, which suffered its strong horizontal thrust in the off plan direction. In 1943, a bomb exploded at the eastern arm of the church destroying it; the shock wave severely damaged the south aisle, while the north was destroyed completely. With reference to the north-facing aisle, the outer perimeter wall of the nave has along the first two rows of blocks a crack pattern characterized by a repetition of vertical slits, which indicates an eccentric compression probably due to a differential subsidence of the foundation ground. This condition could trigger, similarly to what already happens in the nave mirror, the phenomenon of a cylindrical hinge. The imminent failure of the beam and the plinths that serve as the foundation for the head of the aisle would produce the collapse of the same. In this case it is likely a reversal of a simple type, since the reconstruction of the affected area has determined a condition for which the corner constraints with the masonry of the apse are not such as to cause the "dragging" of the tangent masonry. This assumption is made even more remote from the solid structure that supports the under wall Apse.

In order to maintain the current structural condition of the building there are two desirable interventions. The first aimed at monitoring the cracks in order to evaluate their speed of propagation. The second, closely related to the first, aimed at a structural consolidation that in the case of the south-facing aisle determines a condition of counterforce to the eccentric rotation. This condition can be achieved in different ways: burying, for instance, the excavation that runs along the end of the aisle in question. Such intervention would not be invasive to the structure, but would preclude the use of a part of the excavations. Alternatively one could underpin the area affected by subsidence with drilling having an angle of penetration close to 45° from the outside of the building, with subsequent injection of binder within the holes. This intervention, if executed properly, is of minimum impact and ensures the strength of the bond even in the case of alterations of the groundwater level. A third hypothesis could be that of injecting expanding resins of different densities. This solution would have an aesthetic advantage tied to the minimum diameter of the hole required for the application and the considerable advantage of "lift" section of masonry treated. By contrast, a non-perfect control of the mixture and of the relative expansion phase, could create pressures which are not controlled in the soil resulting in leakage of resin in the excavation area. In the case of the north-facing aisle the solution would be to reduce the impact of footings and beam underpinning eliminating corrosion because of carbonation and the subsequent expulsion of the concrete cover. With reference to the central domed portion, it would be advisable to check the behaviour of the tie rods, both those that connect the four pillars and the metal band which surrounds the base of the dome at the extrados. Especially the latter tie would be indicative of an evolution of static equilibrium. Remembering that it has been positioned in the mid 50's and that in 1984 it was inefficient for the occurred tensile rupture. As it always happens when interventions

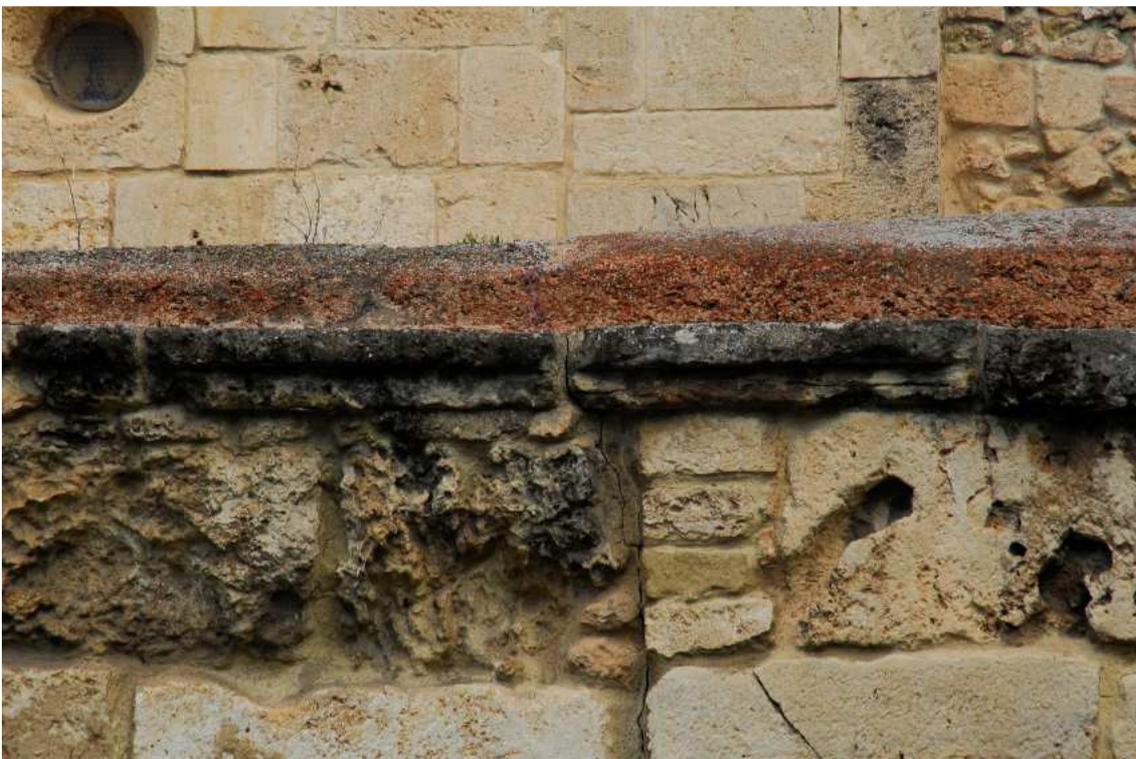
Fig. 7 – Cracks along the Aisle facing South.

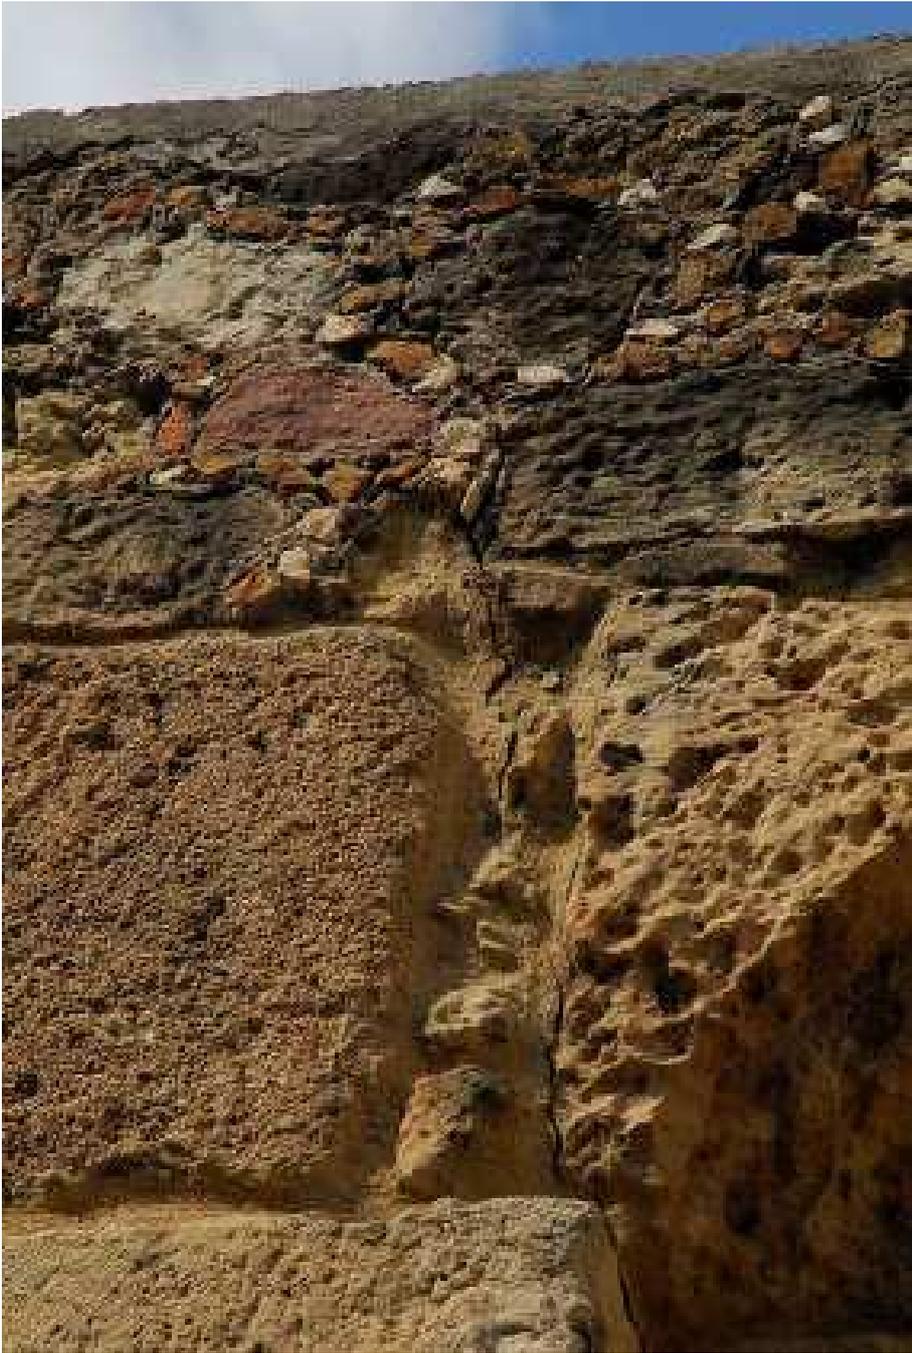
Fig.8 – Cracks along the Aisle facing south.

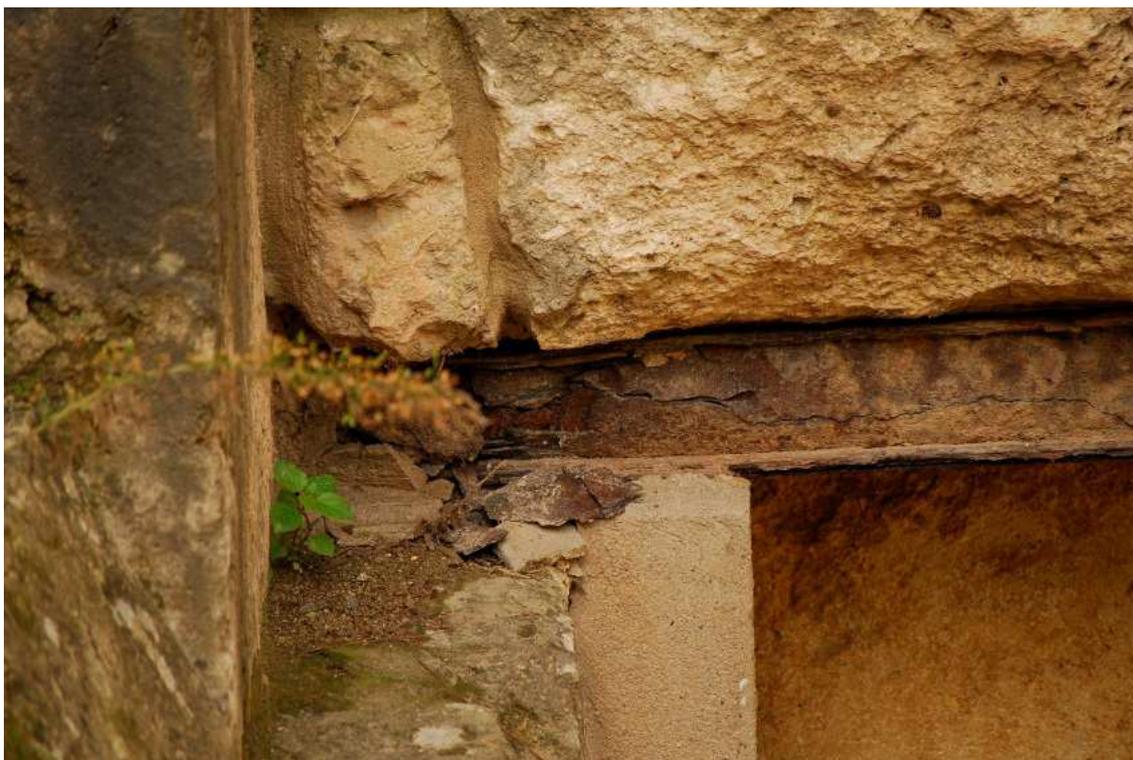
Fig. 10 – Plinth above ground in aisle facing north.

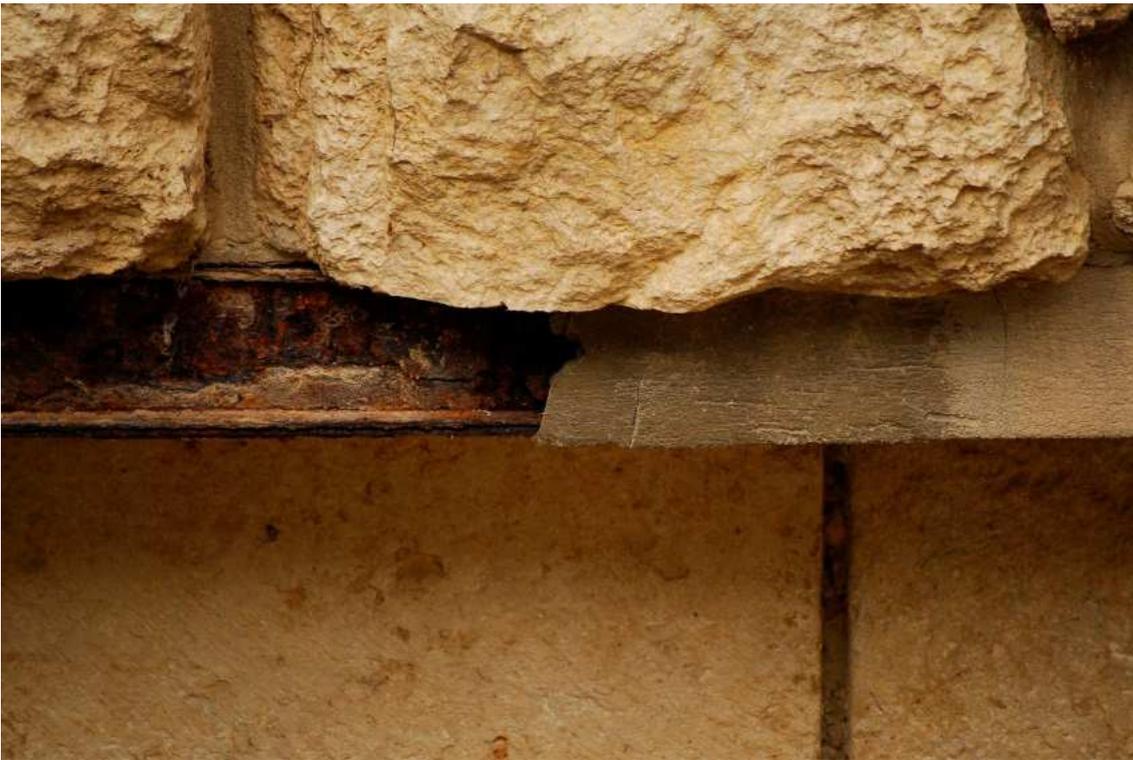
Fig. 11 – Ejecting the concrete cover in the beam on the foundation of the aisle facing north.
