Conservation of Cultural Heritage and Documentation Techniques

Bursa Forestry Museum (Saatçi Ali Pavilion) Conservation Problems and Suggestions

Oğuz YEKE, Faruk Saraç Vocational School of Design, Architectural Restoration Program, Turkey

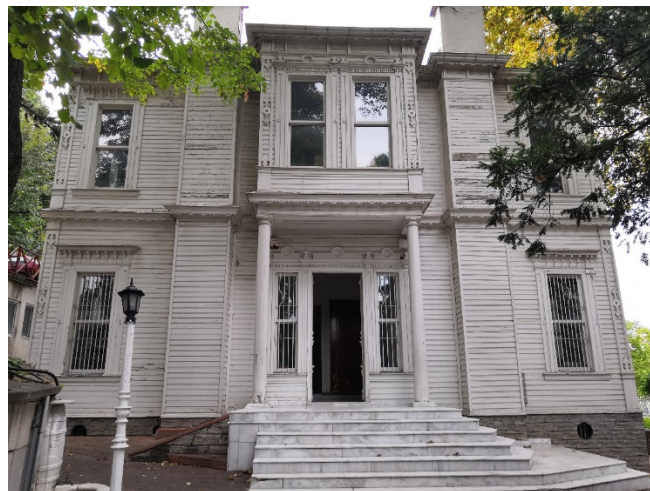
There was no structural damage and serious damage. There are paint spills and joint opening in the exterior cladding. Wooden windows and doors have paint spills. Time-related wear and moisture have been observed on the floor beams in the basement ceiling. There are many layers of paint on the walls of the building and they are poured from place to place. Gypsum plaster made on ornaments on the wall caused great damage to these embellishments. The ceiling coverings in the structure and the decorations made in the painting technique on the canvas are original and damages such as contamination and rupture have been observed to a great extent. On the first floor there are unauthentic wooden elements on the walls and ceilings of the rooms in the southeast. It is considered that roof carriers generally do not have structural damages. Corrosion and buckling were observed in the zinc coating on the windowsills of the building facade. Zinc rain downpipes of the structure have been replaced by unauthentic material in some places.

Fig. 1. Southeastern Façade of the Building and the Main Entrance, Bursa, Turkey (© Oğuz Yeke).

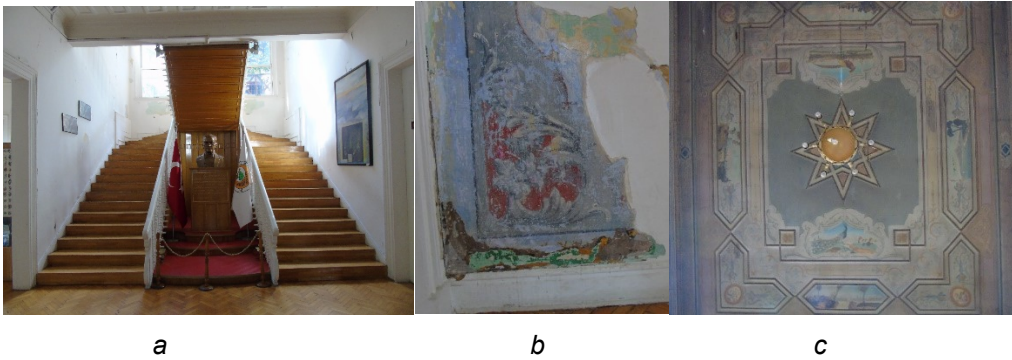
Fig. 3. Forestry Museum inner walls and ceiling ornaments. a) Stair Hall; b) Ornament in Stair Hall Wall; c) Room Ceiling Detail (© Oğuz Yeke).

After examining the building survey, deteriorations affecting the structure, unauthentic additions and situations that need to be intervened were identified and protection recommendations were made. Repairs in line with these recommendations should be done in a way that will cause minimal damage to the original tissue, attention should be paid to the construction technique and materials, and restoration application should be done without changing the internal order of the structure (Ahunbay, 2004). The existing wooden elements in the structure should be painted with paint scraps, and if there are rotting parts, they should be renewed in their original details and materials. The unauthentic coating on the roof should be removed and the necessary reinforcements should be applied. Necessary arrangements should be made in the creeks and ridge on the roof and the existing roof tiles should be replaced with the traditional Spanish tiles. The wooden shutters on the guillotine windows, which were determined from the old photographs, should be rebuilt with original detail and material and replaced. The original wooden flooring should be repaired. The original ceilings in all spaces should be scraped away from paint and decaying and repairing elements should be identified. After the inspection, protective natural wood varnish should be applied and re-painted and replaced.
