Digital survey as a diagnostic tool

A model for the tower of the Castle of Cerretaccio

Ambra MARAMAI, Università degli Studi di Firenze Scuola di Architettura, Italy

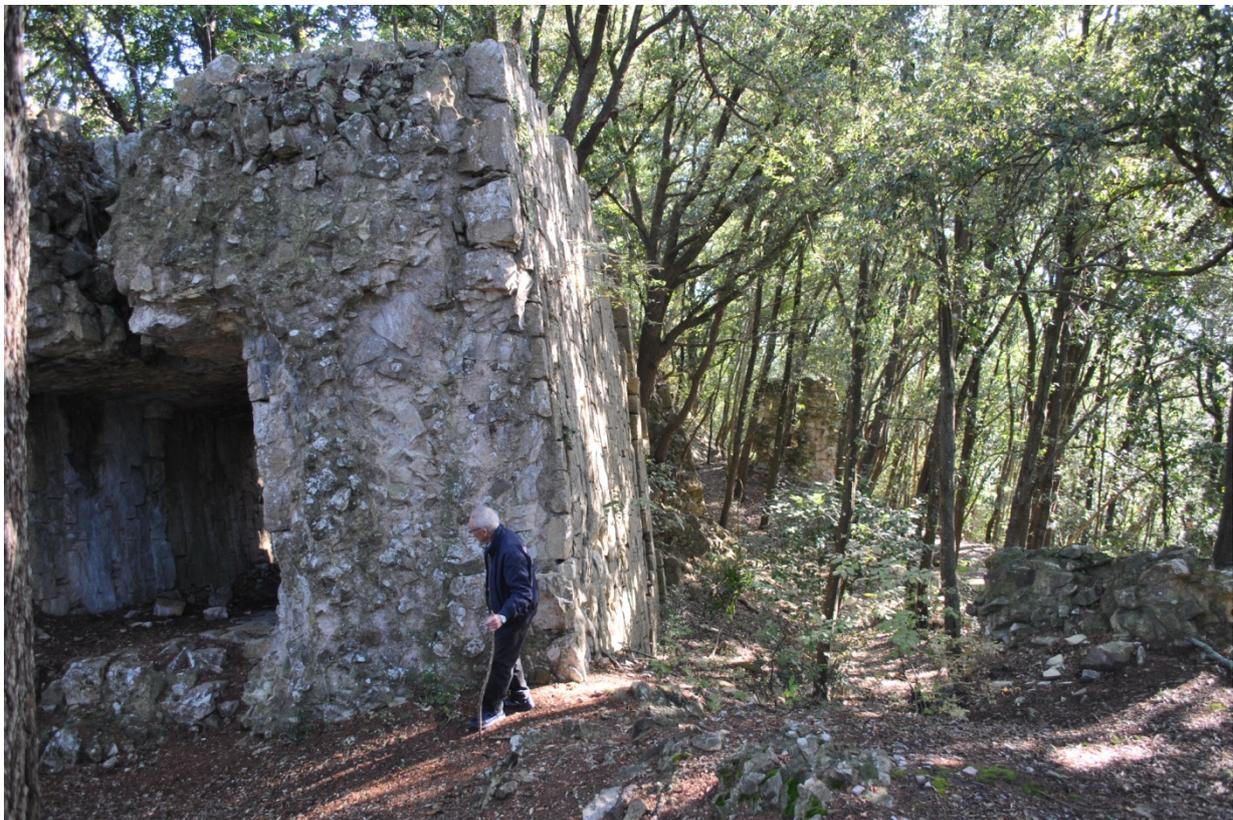
Fig. 1. Tower section.

This is one of the most evident cases in which the digital survey and therefore the production of a 3D model could become not only a representative tool but rather an essential diagnostic tool. By implementing a backward procedure, starting from the various fragments of the tower lying on the ground and going to reassemble them one, up to virtually reconstruct (or physically using a scale model) the original model of the tower, it will be possible to highlight any deficiencies consistent in the foundations, fractures that can be traced back to the seismic action or to the war activity or possibly aspects never taken into consideration.

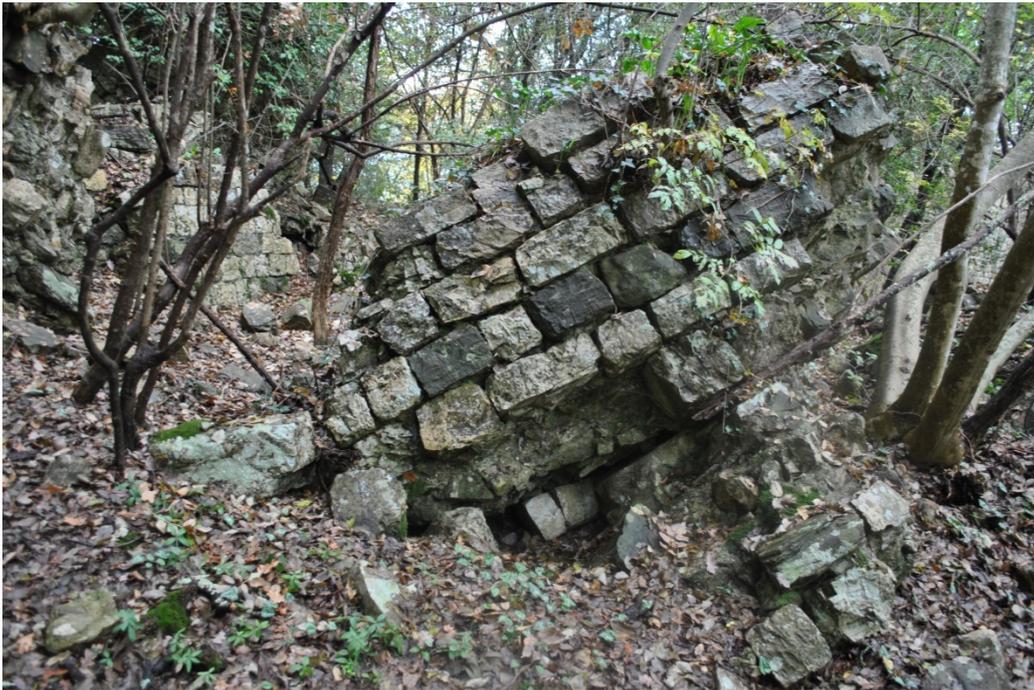
Fig. 2. Some fragments of the tower.

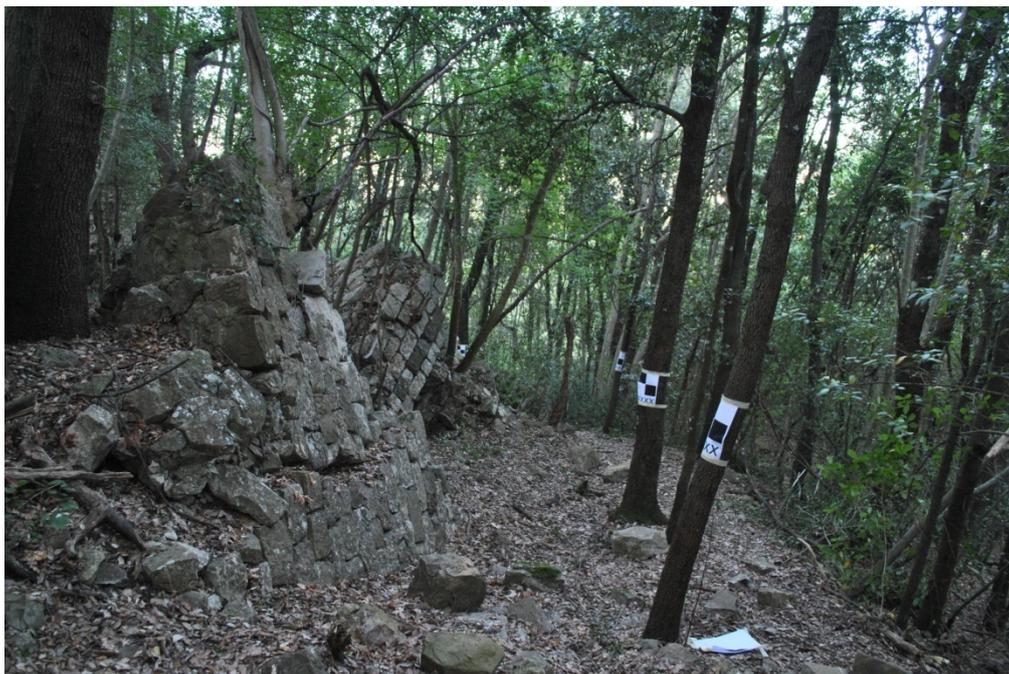
Fig. 3. Digital survey campaign.
