# Documenting and visualizing deterioration of monuments on a 3D environment

## Projection of 2D documentation drawings on a 3D SfM model

Maria ANDROULAKI, Technical University of Crete, Greece  
Georgios VIDALIS, Technical University of Crete, Greece  
Ioannis - Georgios INGLEZAKIS, Technical University of Crete, Greece  
Georgios CHATZIDAKIS, Technical University of Crete, Greece  
Pagona MARAVELAKI, Technical University of Crete, Greece  
Panagiotis PARTHENIOS, Technical University of Crete, Greece

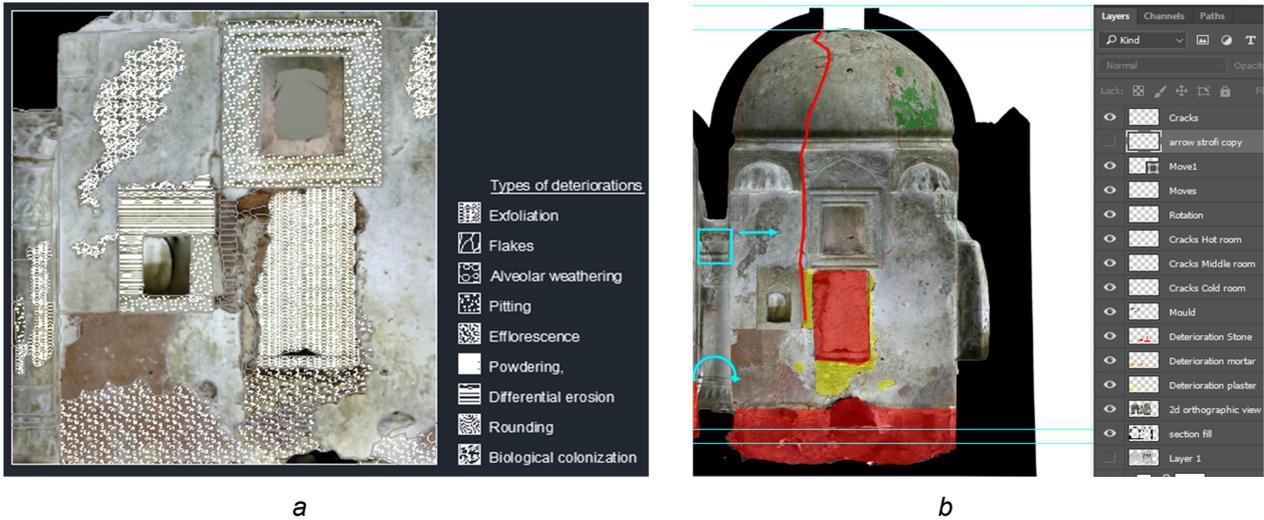
Fig. 1. 2D deterioration visualizations: a) Autodesk Autocad, b) Adobe Photoshop

Two procedures were used to create 2D deterioration visualizations: a) the first one involved the production of .dwg drawings through Autodesk Autocad, where the 2D interior facades were imported as a background, and the layers of the deteriorations were designed using the appropriate hatches (Fig. 1a). b) the second

procedure, focused on the same recording by importing the backgrounds in Adobe Photoshop and processing the visualization of the deteriorations layering separately (Fig. 1b).

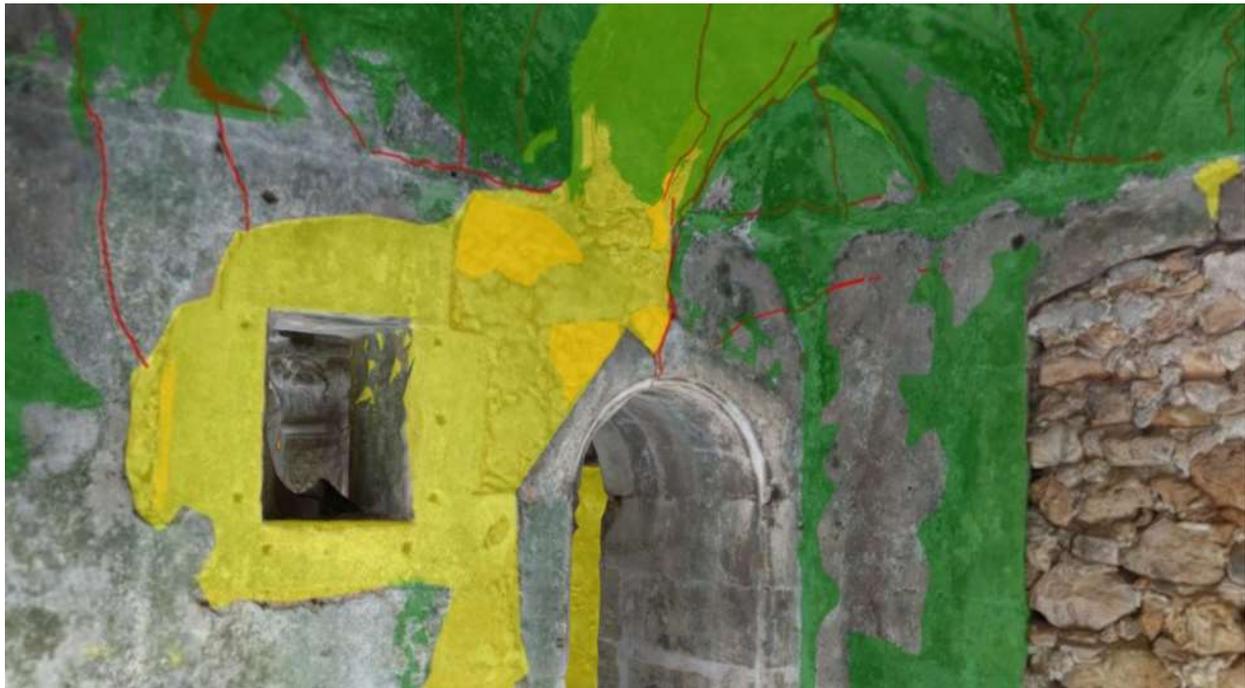
Fig. 2. The final result in the Photoshop 3D environment

The same procedure can be followed for every different deterioration and for every interior view. The final result (Fig. 2), which includes all the deteriorations, is one .psd file for the 3D model and one .psb file relevant to textures with all deteriorations per layer. Inside the Photoshop 3D environment, one can browse the model and observe all the desired deteriorations by turning on/off the layers from the texture file (.psb).
