## Harbour infrastructures from different pasts

### The case of the double abandoned Silos in Livorno, Italy

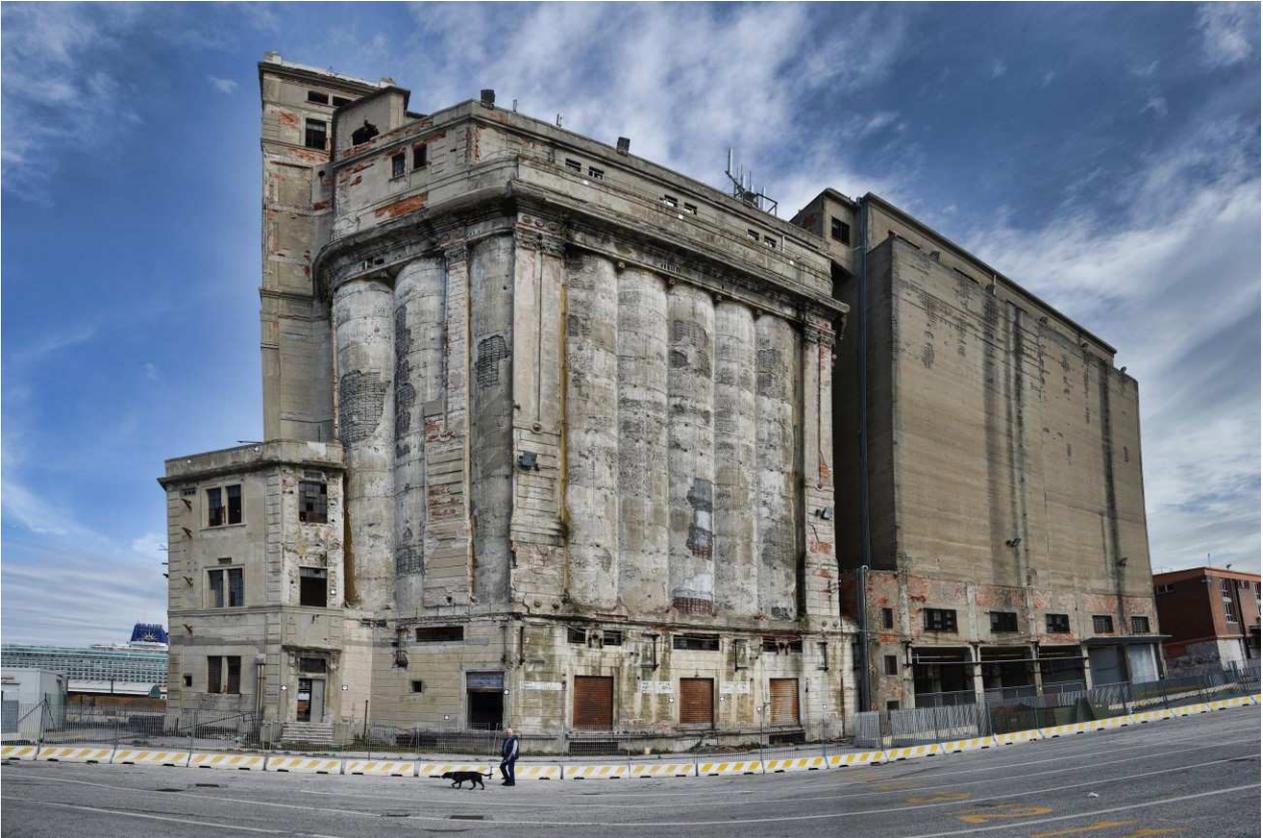
Fig. 2. Silos in 2019.

In the second half of the XXth century, the Silo was restored and expanded in the '60 with a new massive structure, duplicating the volume of the storage area. From this transformation -nowadays still a strong sign in the city skyline- the silos have been in operation for about 20 years, around the 80s the use of this structure was quitted. A progressive degradation of the two buildings began with the newer parts suffering even worse decay than the original building.

The place, taking a central position in the Harbor of Livorno, represents the heart of economy for the city, and the building shows important structural damage and deteriorations; a first intervention should assume their correction as a priority. The proximity to the Fortress of Livorno increases its value as a tourist

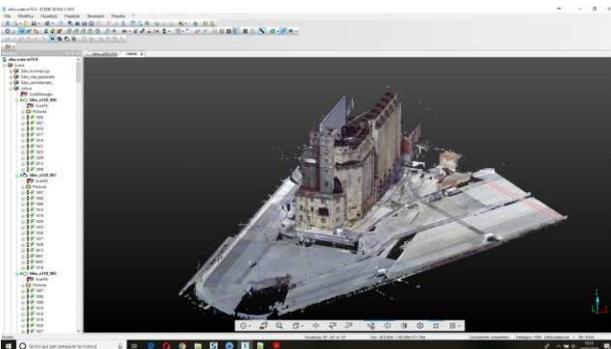
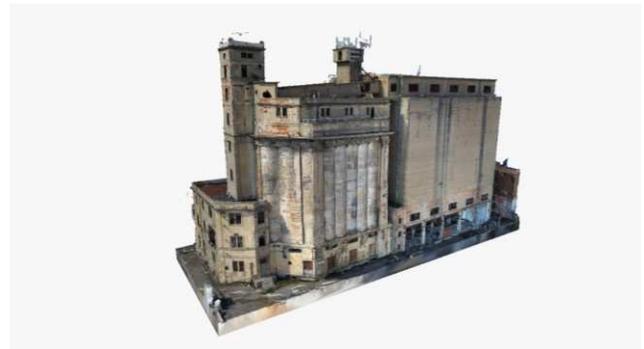
Fig. 3. Digital Survey of the Silos in 2019.

In 2019 a complete digital survey of the whole structure was operated using both 3D laser scanner and photogrammetry, creating the first accurate and updated survey of the building since its construction. The survey work was commissioned by the port authority and operated by and a team from the Team Area3D Srl; Livorno and a team from the Dipartimento di Architettura, University of Florence, coordinated by Prof. Giorgio Verdiani. The resulting 3D models and all its derived drawings are the base for a possible reasoning about recovery and regeneration. The contents of the poster proposed here will analyze this important industrial heritage, describing the specific workflow, the techniques and the procedures used to bring to the end the complex task of documenting a large and massive industrial building without losing a proper level of details on its machineries, decorative details, materials and signs of decay. A complete process from documentation to the challenge of urban regeneration will be presented to share and discuss the best practice in the approach to these kind of buildings/areas (Giugni et al. 1982; Stratton 2000; Soriani, 2002; Kiib 2007).
