# Archaeological documentation during a securing and restoration project: an example of successful approach.

## The case of the castle of Larciano (Pistoia – Italy)

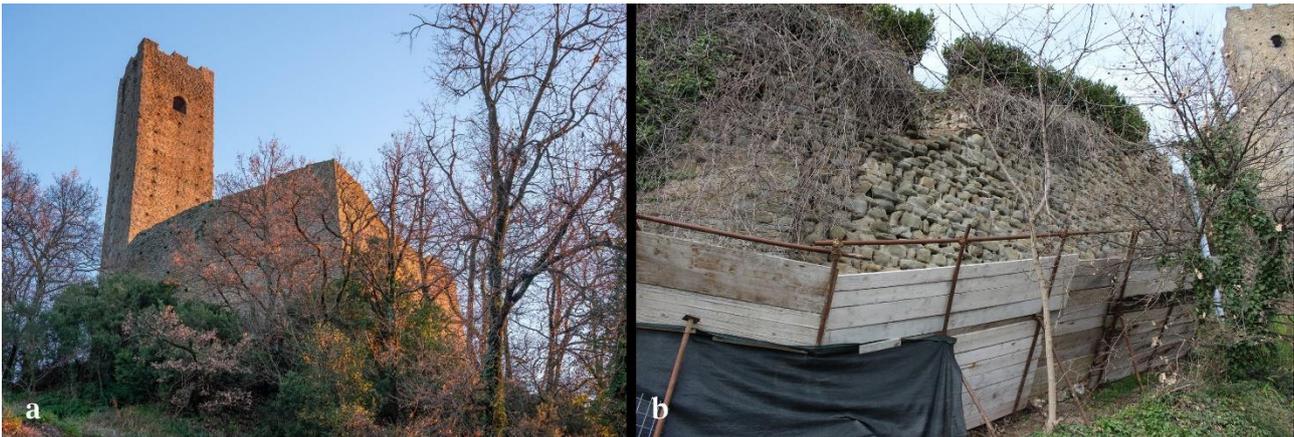
Fig. 1. The fortress of Larciano (a), and part of the eastern wall (b). Vegetation, collapses, safety precautions and the steepness of the ground are visible.

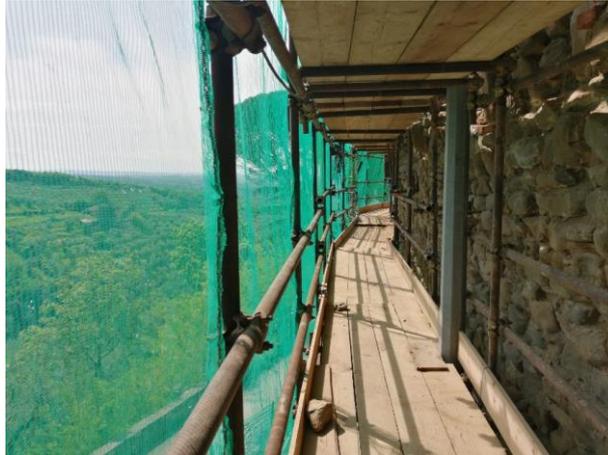
*Fig. 2. The scaffolding of the wall: the floors made hard to obtain vertical overlap and it forced to take very close images*

After cleaning the walls, it was still necessary to document the object, but the scaffolding represented a major obstacle for the photogrammetric survey: it was possible to shoot from no more than one metre away, on 7 different floors, with difficulty in overlapping the various floors due to the scaffolding

floors. On the other hand, not only the entire elevation was visible, but also the crest of the wall, the inner limit, and even a lacuna which, once cleaned, allowed the nucleus of the wall to be seen.
