Pathology detection for HBIM application on a Byzantine church in Axos village in Crete, Greece

Eleni ZAROGIANNI, University of Piraeus, Greece
Konstantina SIOUNTRI, University of Piraeus, Greece
Neoptolemos MICHAILIDIS, Greece
Dimitrios D. VERGADOS, University of Piraeus, Greece

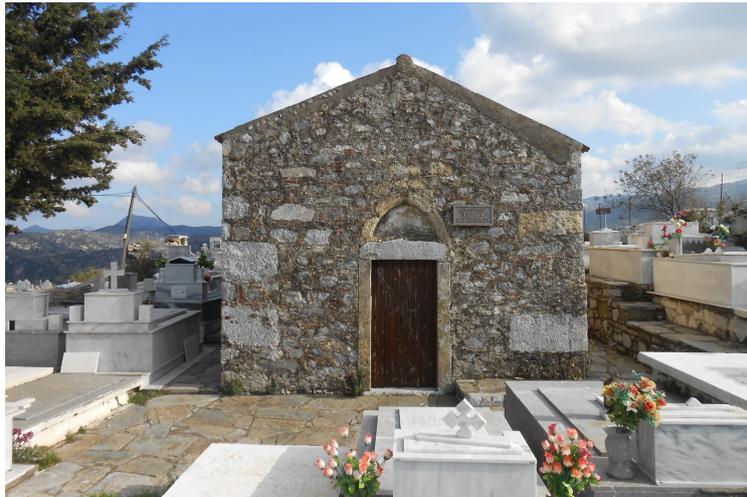
Fig. 1. Western view of St John Prodromos Post-Byzantine Church in Axos, Crete.

The church of St. John Prodromos is located in Crete, at Psiloritis mountain, in Axos village near to town of Rethymnon. The surrounding area is listed as a protected historical location by the Hellenic Ministry of Culture, whereas St. John is the best well-preserved byzantine church in the settlement of Axos. Although a written sign of chronological reference has not been yet found, according to Em. Borboudakis, archaeologist and ex Director of Byzantine Ephorate in Crete, based on his study of the internal frescos, the church was probably built in the first half of 15th century. Church of St. Prodromos is a single-aisled arched church (10x5,15m), with two internal stone arcs for additional structural support and a duo - pitched roof with byzantine tiles (Fig. 1). The in-situ research revealed that the church is built on the remains of an older Christian church. Throughout its life history, the monument has undergone some minor interventions. However, nowadays various problems regarding the deterioration of materials i.e. due to environmental causes (humidity) and the structural integrity due to damages caused by earthquakes taking place in the area. In the interior, the church is fully painted with frescos representing numerous instances from St. John's life, as well as other Christian-Orthodox ceremonial subjects and Saints images. The historical frescos nowadays are in bad condition due to humidity. For that reason, a detailed survey and a database with information such as frame dimensions and location, painted forms and pathology has been executed.

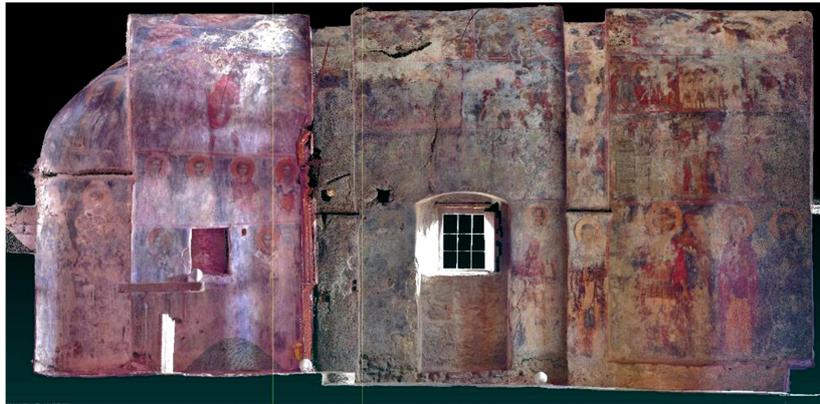
Fig. 2. Orthophoto of the north facade of St John Prodromos Church in Axos..

Architectural survey was executed by using Faro's 3D Multisensor Focus Laser Scanner, using spheres as reference points. The accuracy was determined at 6,15 mm and included four repetitions per scan (England, 2018). Finally, 17 scans were produced and the whole procedure was carried out, allowing the engineers to gather all data needed for a restoration study, on a single working day. Faro Scene was used for point cloud optimization, smoothing and filtering, as well as creation of orthophotos, while highly accurate architectural designs were made using Bentley Pointools View, saving a significant amount of effort and time comparing it to traditional methods. As far as the pathology diagnosis, in order to deal with issues concerning the highest possible level of accuracy (cracks, shape of the arches etc), a methodology using digital processing of selected orthophotos was followed. This technique was chosen as the best applicable one since the whole church is covered with frescos inside, making existing cracks difficult to mark and notice. This phenomenon is worsened by the high level of humidity which had created large blackish areas on the facades. Digital processing including removal of the RGB filters and controlling of orthophotos' level of intensity was carried out in all interior surfaces, making frescos disappear and cracks appear clearly on the walls and arches (Fig. 2, Fig. 3). Although the initial intention of the study included using Revit for the whole project, architectural designs of pathology were finally made in AutoCAD, because the highest possible level of accuracy was needed as far as it concerns geometry. This methodology allows scientists in the field of cultural heritage

Digital processing of orthophotos for crack detection can be used not only on pathology survey, but also on monitoring of the structure through time, arriving to significant conclusions about gradual deterioration of a building and necessity of urgent interventions. This methodology allows researchers to reach accurate results, having spent the minimum possible time on site and contribute to the HBIM documentation of cultural heritage.
