Structural analysis and evaluation of interventions for the protection of the Resurrection of Christ by Piero della Francesca mural painting at Sansepolcro

Anna Livia CIUFFREDA, Department of Earth Sciences, University of Florence, Italy
Massimo COLI, Department of Earth Sciences, University of Florence, Italy
Michelangelo MICHELONI, Department of Earth Sciences, University of Florence, Italy

Keywords: Resurrection of Christ, Piero della Francesca, Sansepolcro, Seismic hazard, FEM.

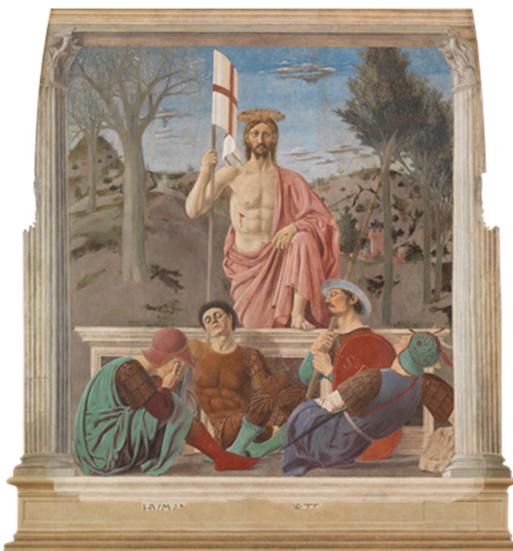
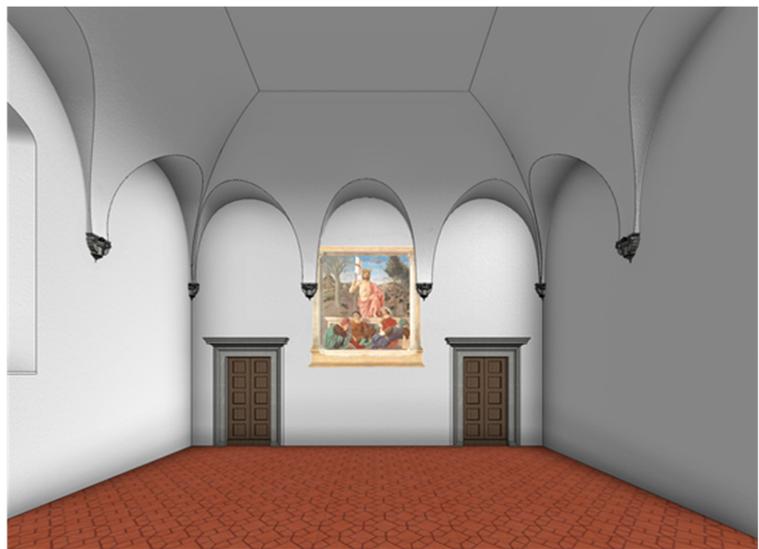
Figure 1. The Resurrection of Christ by Piero della Francesca in the Sansepolcro museum (courtesy by the Sansepolcro Municipality) and a view of the BIM model.

The Resurrection of Christ mural painting (Fig.1) was realized by Piero della Francesca about 1460 on a brick wall (15 cm thick) placed in a different place as it is today. Shortly later, the painting was moved by means of a transport to solid-wall and placed against a pre-existing wall (60 cm thick), where it is today, erecting against this wall a counter wall (15 cm thick) where the mural painting wall-panel (225x200 cm) had been inserted. The existing wall is not jointed to the two main lateral walls.
