Wrecks in Transition

Monitoring of shipwreck transformation processes using Structure from Motion

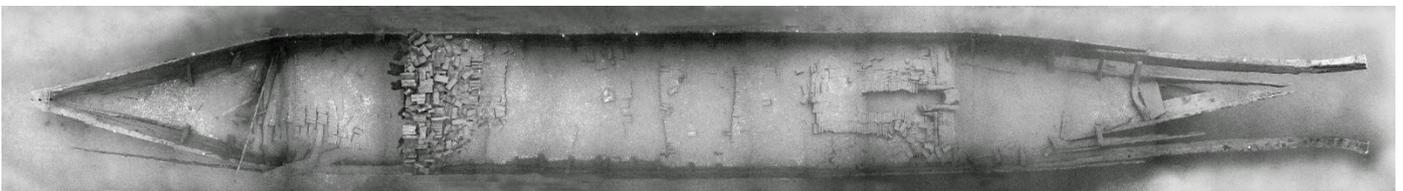
Fig. 1. Condition of the shipwreck ZIEGELWRACK in 2012 (© Kaffenkahn e.V.).

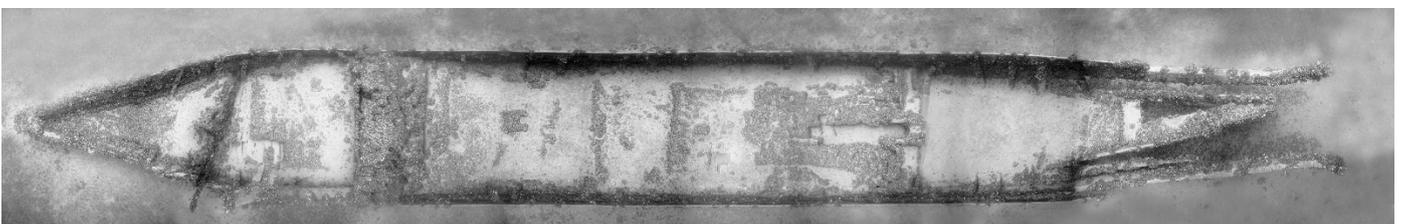
Fig. 2. Condition of the shipwreck ZIEGELWRACK in 2019 (© Kaffenkahn e.V.).

In the last ten years, especially those wrecks have been systematically documented, which lie in a depth of up to 25 m and are therefore easily accessible for divers. In particular, the application of the Structure from Motion method and the use of orthophotos makes the massive and rapid changes to the shipwrecks visible. On the one hand, these changes can be attributed to a changed ecosystem due to immigrant species. On the other hand, looting was noted, which was rarely noticed before the systematic documentation and could only be reported to the responsible authorities in individual cases. Using the example of the so-called ZIEGELWRACK, the importance of an annual monitoring of shipwrecks is shown in order to document the natural and anthropogenically influenced decay of the historic wrecks. The results of our monitoring in the years from 2012 to 2019 have shown that the physical structure has already changed dramatically over the past seven years of observation. In addition to the loss of individual components, such as frames or planks, the theft of bricks, that is parts of the cargo, can be observed. Furthermore, the entire wreck is overgrown with shells that have a strong impact on the appearance and decay process of the shipwreck.
