# Yeni Hammam: History in Graffiti

## Catalogue of images found in plaster layers in an Ottoman bathhouse in Plovdiv

Nina TOLEVA-NOWAK, University of Architecture, Civil Engineering and Geodesy, Bulgaria

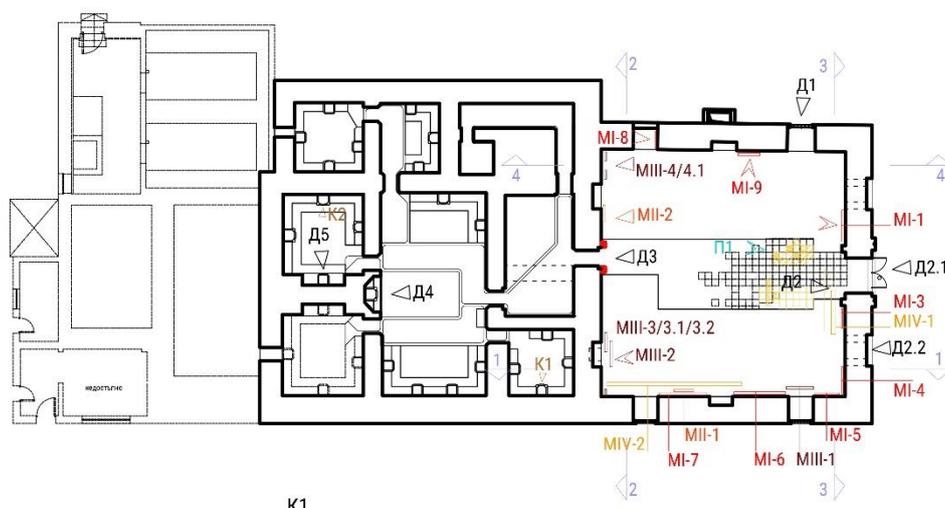
The author explores the history of the building by creating a complete catalogue of all the medieval graffiti and the murals from the Revival period, revealed in the plaster layers (Fig. 1), and thus puts the monument in national and international context referring not only to the eastern ottoman bath tradition and construction, but also to the western decorative practices.

Fig. 1. Scheme of murals location (© Nina Toleva-Nowak).

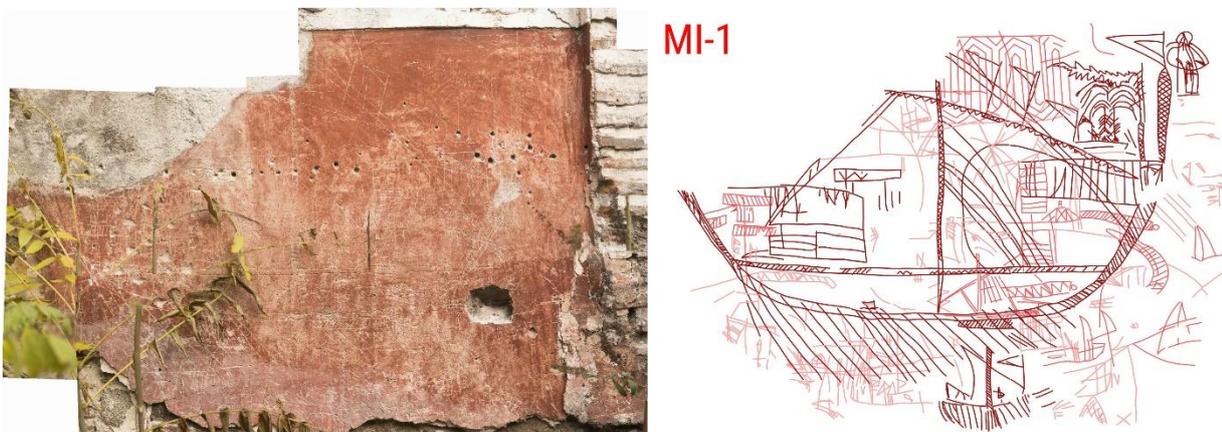
*First period:* The building was erected during XVII century (1630-1640), based on the Ottoman Tax Archives. It was located between the Turkish and the Jewish Quarters, tangent to one of the main commercial routes from Vienna to Constantinopol. It functioned as a bath with few minor repairs. By the end of the XVII century the windows on the front façade were narrowed and new plaster layers were laid. Numerous graffiti drawings are also revealed in this layer (Fig. 1). The pigments used are in the dark range - cinnabar, ocher, black. The elements vary – letters from the alphabet, geometric shapes, scribbles, ships, warriors and fish shoals (Fig.2). They are in extremely fragile state, yet the author managed to document them all. Similar types of graffiti can be observed in medieval churches all across Europe – Greece, Macedonia, France, Britain, etc.

Fig. 2. Graffiti drawings (© Nina Toleva-Nowak).

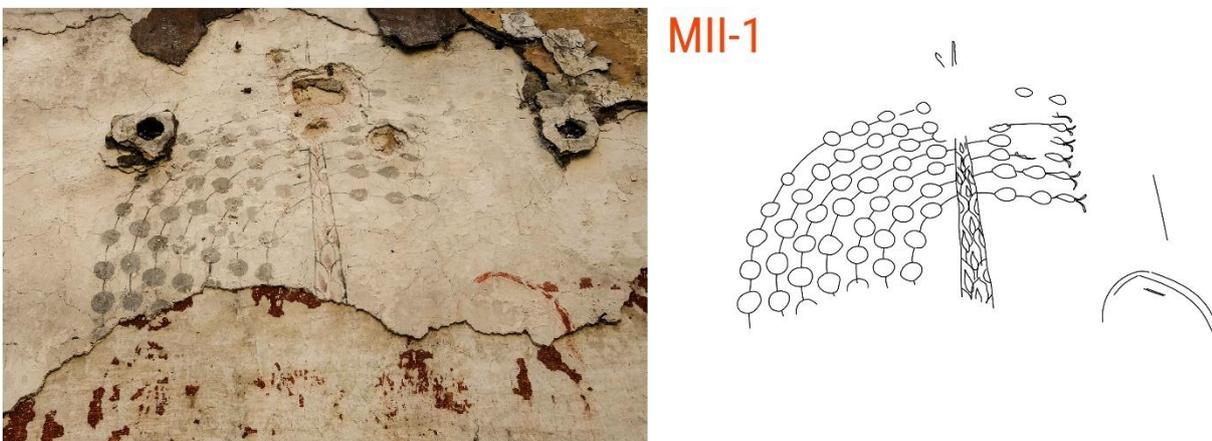
*Second period:* In the next plaster layer, traces of two bird images, most possibly peacocks, are found (Fig. 3). A similar technique of depicting tail and neck feathers is found in medieval manuscripts in both the Western and Eastern traditions (Manuscript Sacramentarium gelasianum, Psalter Netherlands, from Utrecht, 1290, Kalila and Dimna - 1310, Kitab Na't al-hayawan wa-manafi'ih, 13th century and Aja'ib al-makluqat - The Miracles of Creation by Al-Qazwini, early 15th century).

Fig. 3. Peacock detail (© Nina Toleva-Nowak).

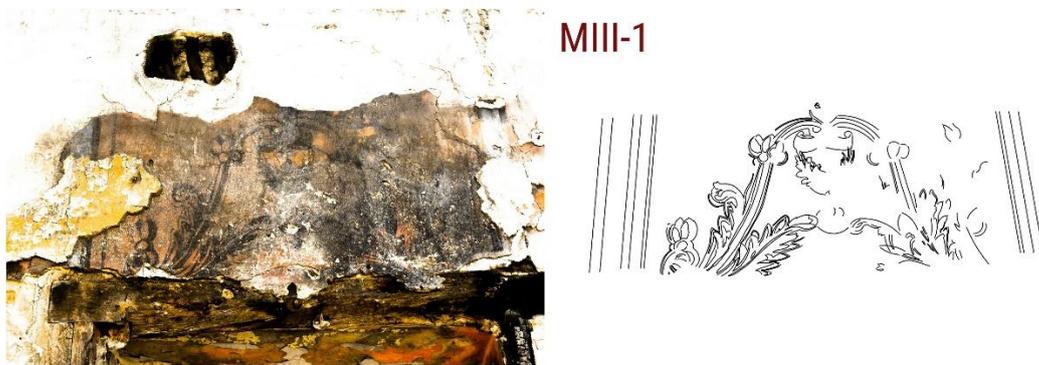
Third period: After several earthquakes in the first third of the XIX century, the urban landscape of Plovdiv was heavily damaged. One of the most devastating earthquakes was the one from 1818 and it was the one that probably led to the demolition of the original masonry dome and the construction of new wooden one, which can be spotted on later photos from 1892. The plaster layer is characterized by saturated, dark colors, executed entirely in the spirit of the frescoes from the first period of the Revival frescoes corresponds with the time period and is heavily influenced by the Western Baroque - lavish hand-painted ornamentation with the rhythmic demarcation of the mural panels (traced throughout the height of the dressing room), reinforced with black ribbons and lines in Turkish blue and ultramarine, are severely damaged and can be traced only in fragmentary fragments (Fig. 4). The author is currently working on a restoration project based on the documented elements.

Fig. 4. Early Revival murals(© Nina Toleva-Nowak).

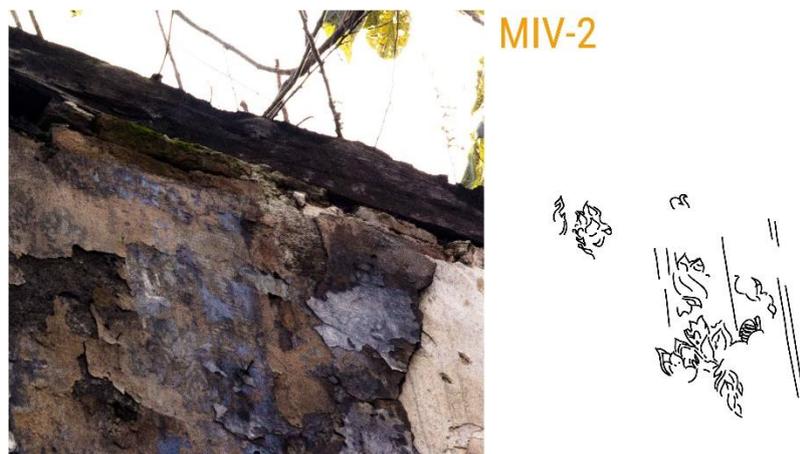
Fourth period: The next plaster layer is characterized by bright, colorful chromatics (white, Turkish blue, yellow, black) and remnants of painted architectural elements - columns, railings, vases. The way of writing is typical for the Mature Revival (the second third of the XIX century). Unlike the previous plaster layer, here the ornamentation develops in height - the preserved fragments are at the level of the second floor, around the windows. Given the classical proportions of the painted columns (Fig. 5), and given the growing population of the city and the need for more infrastructure, probably in this period the wooden gallery in the locker room appeared. Its presence is documented in the photographs archived in National Institute of Immovable Cultural Heritage during survey from 1980s. The window openings on the second level were probably drilled in the stone wall during that period. Unfortunately, this plaster layer is heavily damaged and its reconstruction is becoming more and more challenging.

Fig. 5. Late Revival murals (© Nina Toleva-Nowak).
