Relations between static-structural aspects, construction phases and building materials of San Saturnino Basilica (Cagliari, Italy)

Stefano COLUMBU¹ | Antonio CAZZANI² | Alessandro RUGGIERI³

Proceedings of the 19th International Conference on Cultural Heritage and New Technologies 2014 (CHNT 19, 2014)

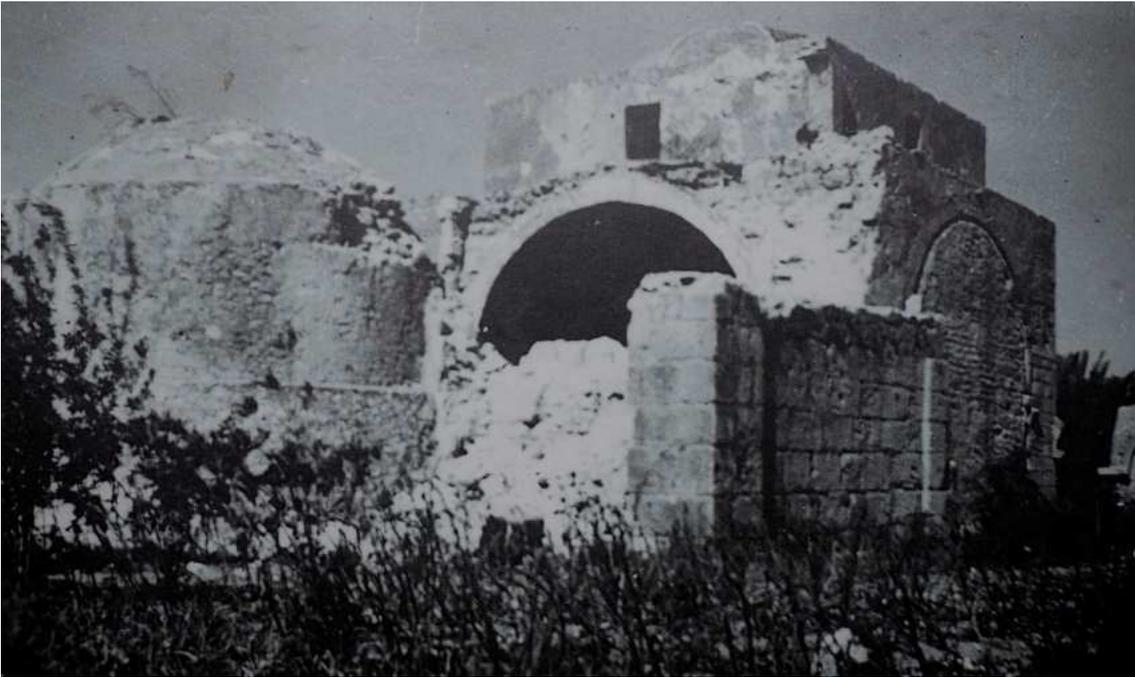
Fig. 9 – Church of San Saturnino after the bombings of World War II, image property of the Superintendence for Architectural, Landscape, Historical, Anthropological Heritage of Cagliari and Oristano.
