‘Petrification’ of Brussels architecture

An attempted explanation between construction methods, supply of building materials and social context (13th-17th centuries)

Proceedings of the 17th International Conference on Cultural Heritage and New Technologies 2012 (CHNT 17, 2012)

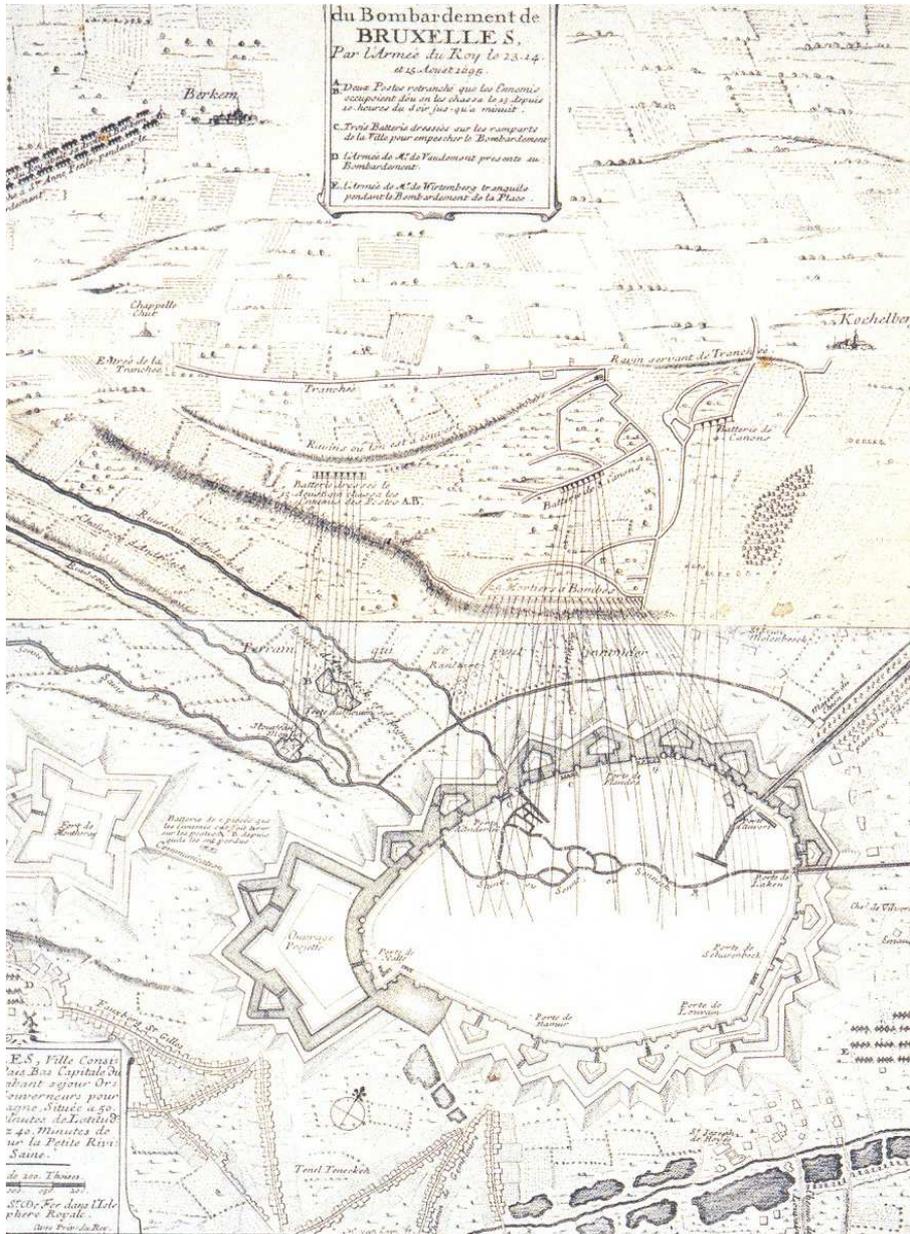
Fig. 1– Map of Nicolas de Fer illustrating the bombardment of Brussels in 1695 by French troops of Louis XIV (© Royal Library of Belgium)

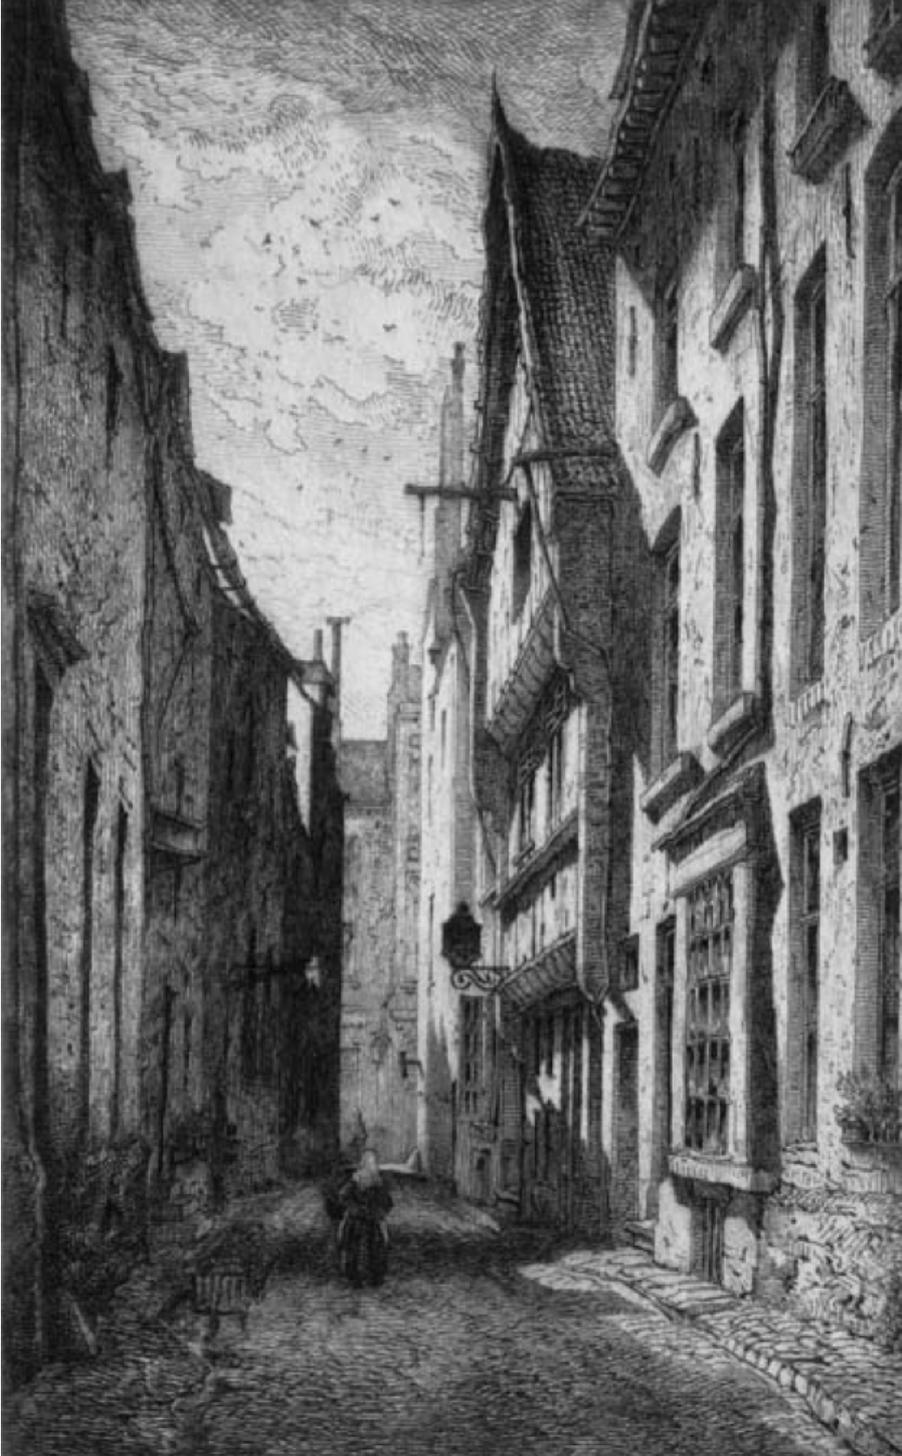
Fig. 2 – Corbelled wood façade in the Rue des Pierres. Engraving by Emile Puttaert, 1878 (© Archives of the City of Brussels)

The study of timber-framed structures and the ‘petrification’ of architecture is still a fairly new field in archaeological research in Brussels. Nevertheless, these construction methods are widely documented by iconography and written documentation from the 15th, 16th and 17th centuries as well as, indirectly, by various edicts enacted by the city, in trying to make away with them (CHARRUADAS, HAGELSTEIN 2004; HOUBRECHTS 2011; CHARRUADAS 2011). According to traditional thinking, the bombardment of Brussels in 1695 by Louis XIV’s French troops would have removed the last traces of this wooden architecture. During the bombardment, several thousand red-hot cannon balls were directed at the city and nearly 4,000 houses were destroyed (FIG1). This widespread destruction, followed by a long period of reconstruction, reinforced the ban on corbelled frontages. Two elements, which question the relevance of this presumed end to wooden constructions, can be highlighted. First, it is to be noted that only about one third of the city was really affected by the French bombardment and second, several representations, including a 19th century engraving and some photographs from the beginning of the last century (FIG2), indicate the persistence of

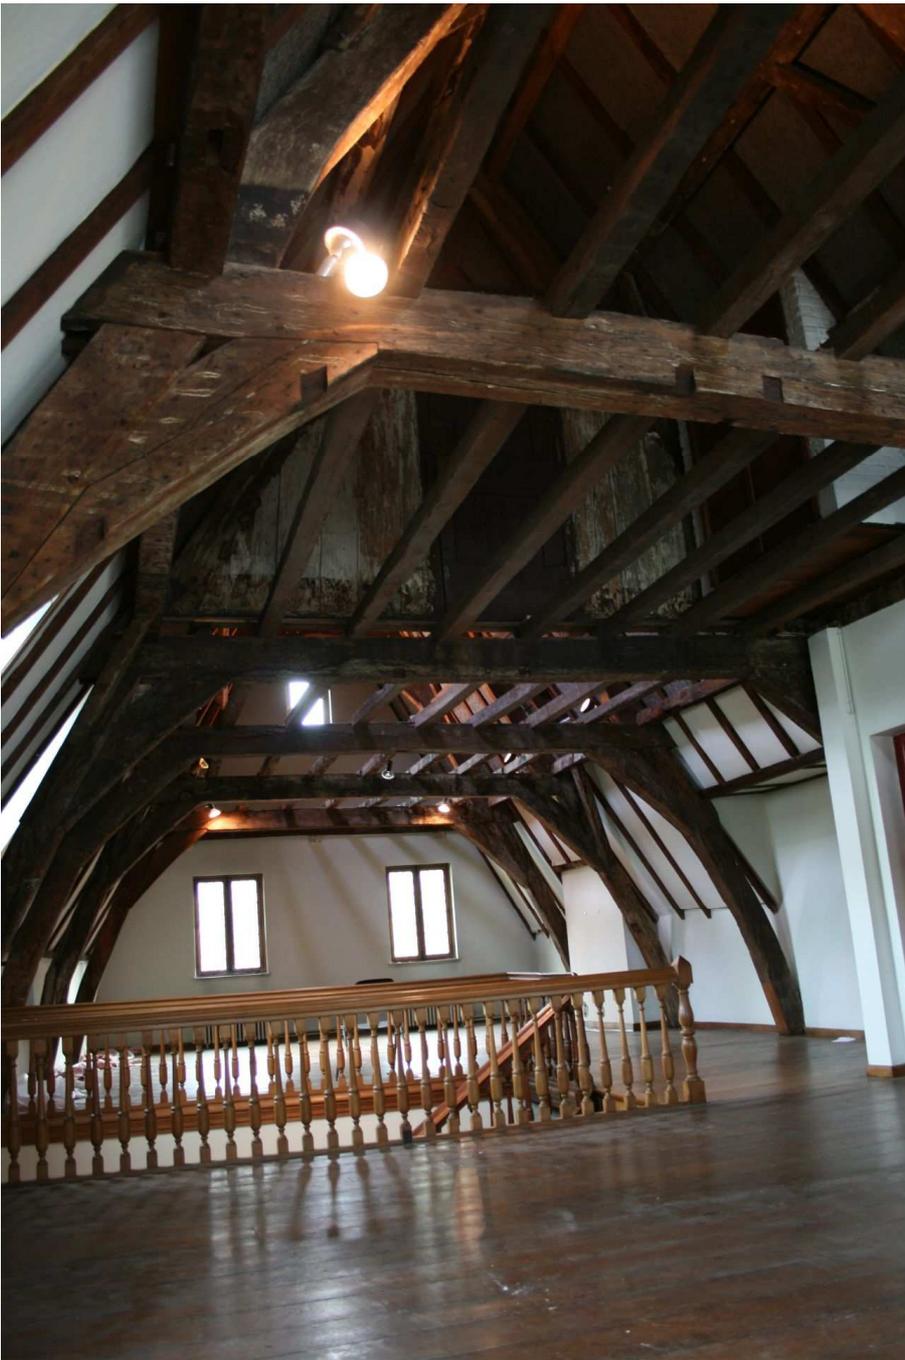
Fig. 4 – Roof frame of the house Brueghel, Rue Haute, no. 132 (© CReA-Patrimoine, ULB)

In two cases, a dendrochronological dating was obtained: the house called "Brueghel" at 132, Rue Haute was dated between 1540 and 1545 (FIG4) (HOFFSUMMER, MAGGI, WEITZ 2012). The second site, located in the same street at no. 4, goes back to the year 1543 (FIG5) (EECKHOUT 2007). For two other houses (180, Rue de Flandre and 120, Rue de Laeken), a date could not be obtained for the reasons mentioned above. Concerning the house located Rue de Flandre, the cores have been subjected to analysis by AMS 14C. The results indicate a construction dated between the 14th century and the first half the following century (VAN STRYDONCK 2011; VAN STRYDONCK 2013) (FIG6). For all the buildings under review, archaeological investigation indicates that the sidewalls are the first ones to be "petrified" with full brick masonry. The study of the brick bond and the morphology of the bricks offer a wide chronological range between the 15th and the 16th centuries. In the case of the house 180, Rue de Flandre an AMS 14C dating of charcoal residue in the original lime mortar has situated the construction of the sidewalls between 1290 and 1410, roughly the 14th century (FIG7). The next phase sees the construction of the back wall in brick and stone during the 16th century, leading perhaps to what some archaeologists call the "three-quarter house" (BYL, CHARRUADAS, DEVILLERS, SOSNOWSKA 2012). At this point only the frontage is still in timber. This type of structural change is still very common in the 17th century on the main market square of Brussels, the Grand'Place, and its various corporation houses (MARTINY 1991; HOUBRECHTS 2011). We must question the true extent of this diagnostic and the reality of these 'three-quarter' houses. Research in the city of Ghent has discovered one example of a petrified front facing the street, while the back wall, overlooking one of the local rivers, is still in its timber-framed structure (EVERAERT, LALEMAN, LIEVOIS 1992). What value is attributed to these wooden frontages? What is the meaning of the continuous construction of timber-framed houses on the Grand'Place in the 17th century, while brick architecture developed from the 15th century onwards? As for the symbolic importance of the stone house, the *domus lapidea* – heavily emphasized in the written sources – should it be qualified? Must we apprehend a symbolic value in this discussion, linked with the well-known conservatism of the corporations?

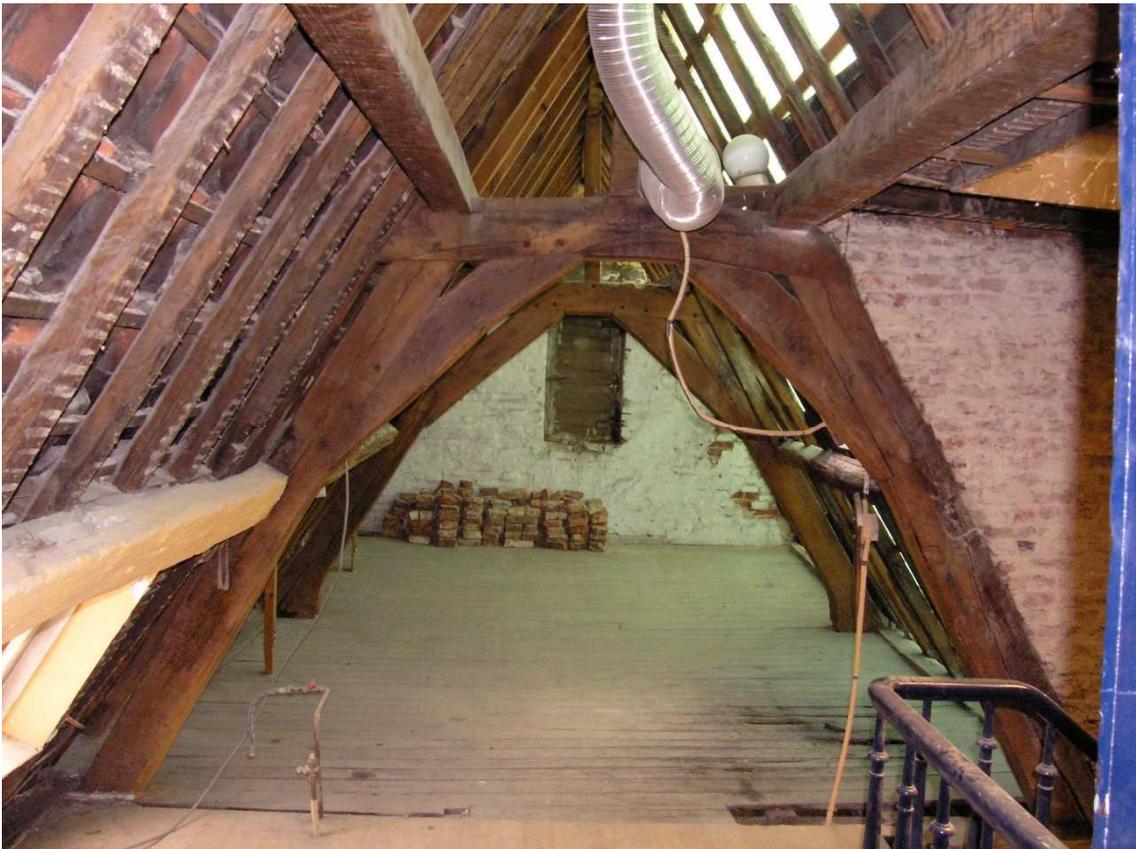
Fig. 5 – Roof frame of the back house located Rue Haute, no. 4 (© Royal Museum of Art and History, Brussels)

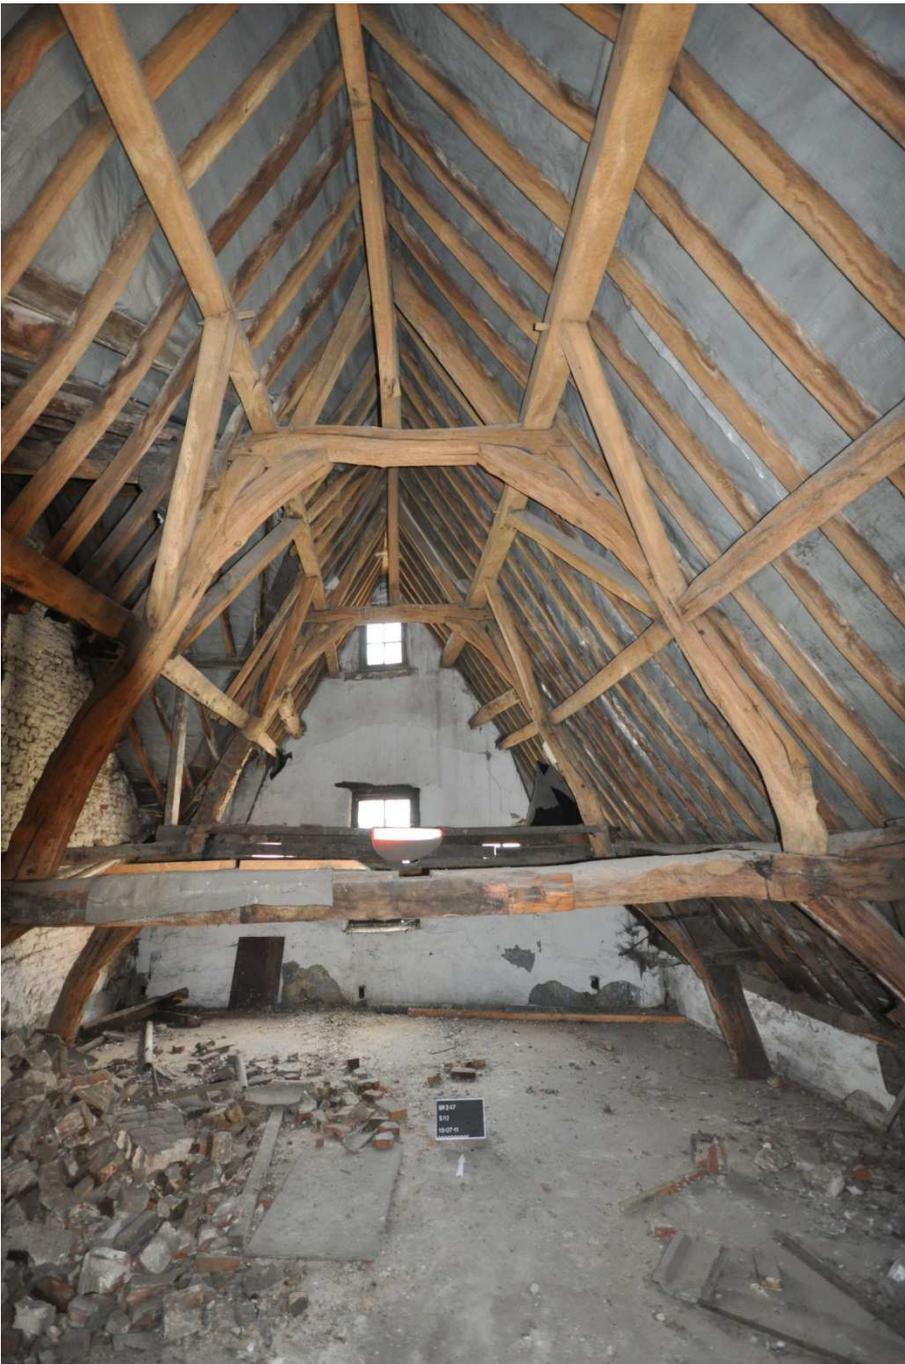
Fig. 6 – Roof frame of the house located Rue de Flandre, no. 180, dated by AMS 14C from the period 1390-1450 (© CReA-Patrimoine, ULB)

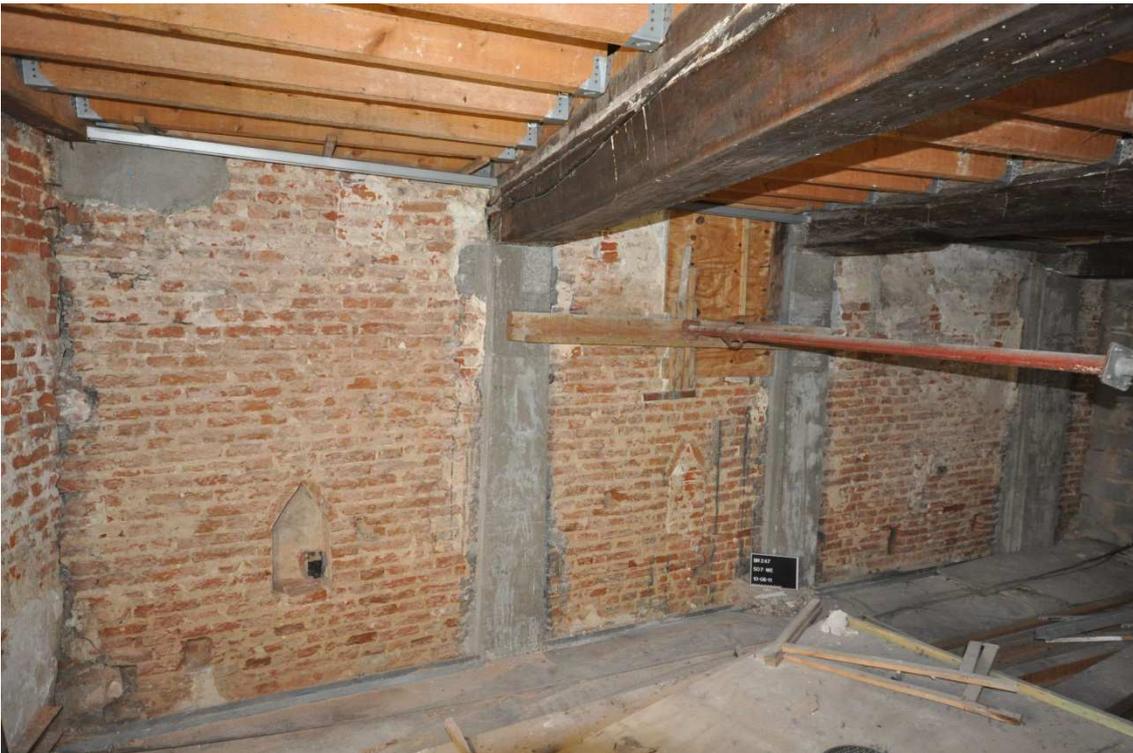
Fig. 7 – East Sidewall of the house located Rue de Flandre, no. 180, dated by AMS 14C from the period 1290-1410 (© CReAPatrimoine, ULB).

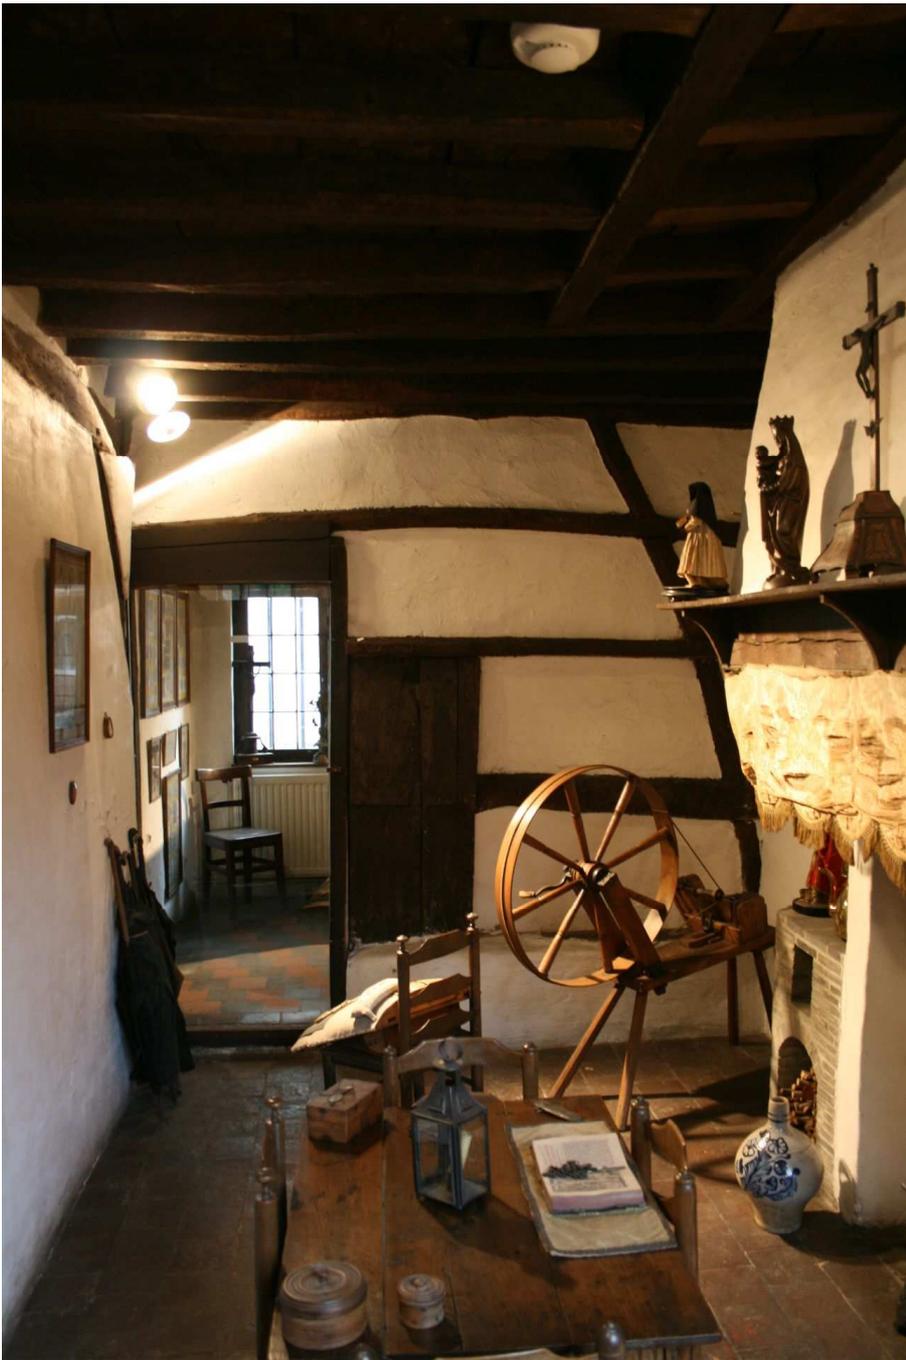
Fig. 8 – Ground floor of the Beguinage of Anderlecht. View of the timber frame dated from the first half of the 15th (© CReA-Patrimoine, ULB)

Three timber buildings were identified in the rural area. Two are dated before the 18th century and one in the 19th century (CHARRUADAS, SOSNOWSKA, coming soon). Two cases explicitly characterize this phenomenon of ‘petrification’; first, the small beguinage in Anderlecht in south west Brussels. This site comprises two buildings built in parallel. One contains a timber-framed structure dated by AMS 14C in the early 15th century, making it one of Belgium’s oldest timber constructions (FIG8). The building includes two well-preserved facades, four trusses and a division wall (FIG9). The structure is not built in oak but combines ash and Mahaleb cherry (*Prunus mahaleb*). The use of this type of resource remains little highlighted in Belgium. At the end of the 17th century, the ancient timber building was included in a new brick construction. Two facades have therefore been removed and underpinned. The other two façades have been preserved and were incorporated into the new construction. The widening of the west side and the extension of the building to the south necessitated the construction of new structures and a new oak truss to supplement the original frame. The ‘petrification’ process was deliberately minimized through the maintenance of a series of structures. The constructive logic of adaptation can be seen here; the re-use of older structures is both labor-saving and involves reduced construction costs (CHARRUADAS, SOSNOWSKA, coming soon).

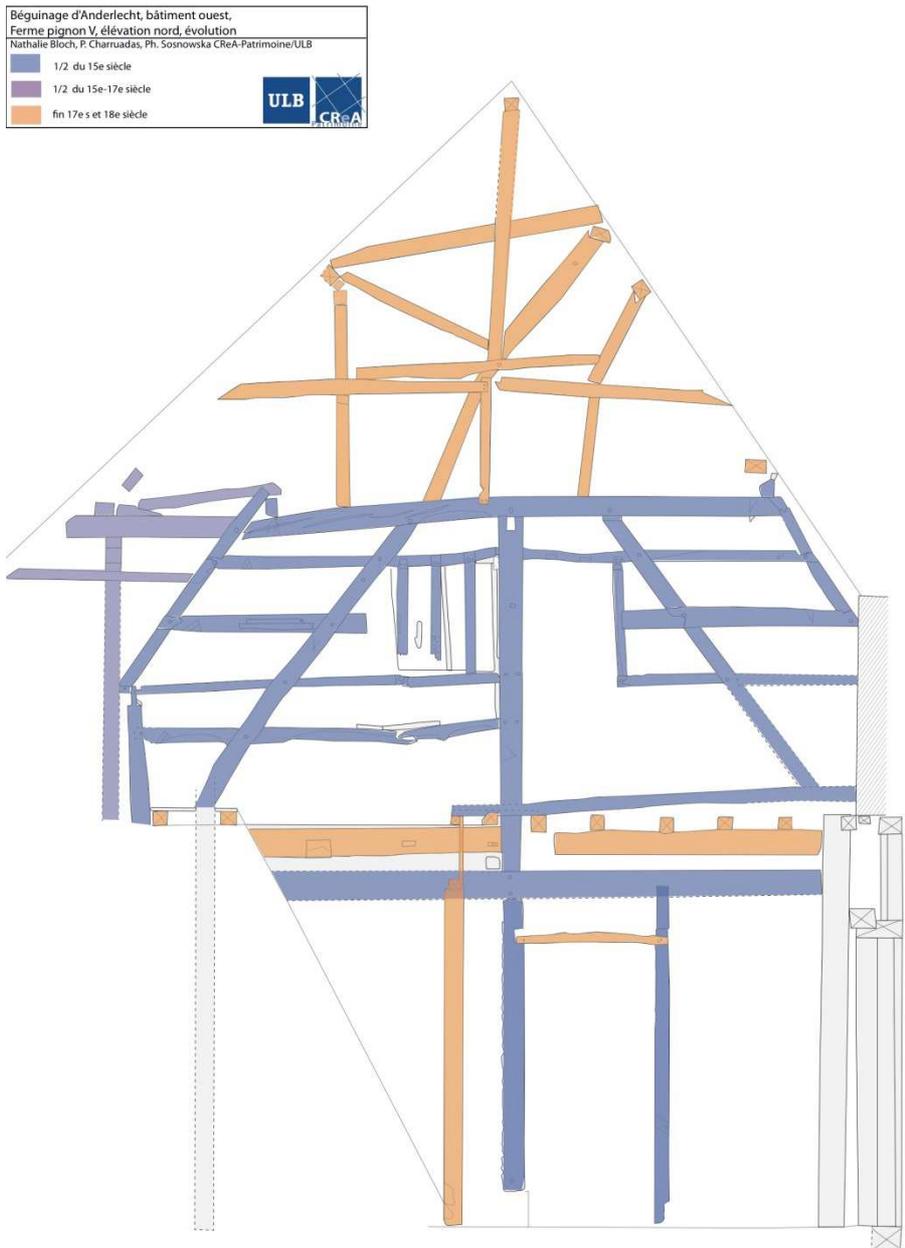
Fig. 9 – Béguinage of Anderlecht. Archaeological record of the timber-framed façade (truss V) with later modifications

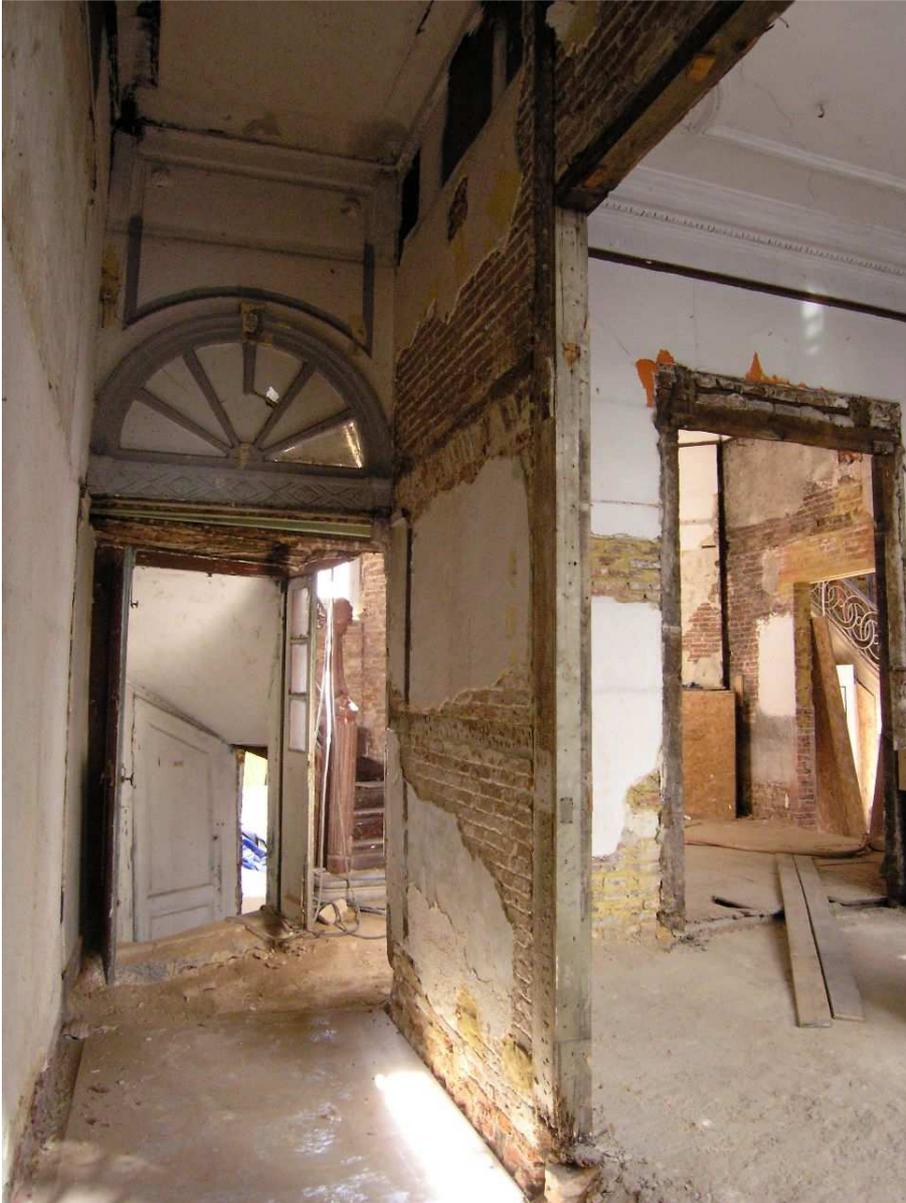
Fig. 10 – Timber-framed structure in the Dewez house, Rue de Laeken, no. 72-75, dated from the period 1789-1799 (© Royal Museum of Art and History, Brussels)

The Dewez house, located at 72-75, Rue de Laeken, is a striking example. The entire house at no. 75 was built around a wooden structure, roughcast with bricks, except for the side walls and the facades. This part of the house was built by Laurent-Benoit Dewez, first architect of the court of the General Governor of the Austrian Netherlands, Charles of Lorraine, between 1789 and 1799 (FIG10) (SOSNOWSKA 2012). It is a genuine timber-framed structure visible on several levels. Similar cases are widespread throughout the city. There even seems to be a constant: 59, Rue des Bouchers, 3, Quai aux Bois de Construction, the Hotel de Merode on Place Poelaert, 38, Rue de la Violette, and 36, Rue des Pierres. We even found these timber-framed walls roughcast with bricks as separation walls between properties and/or houses. This is often the

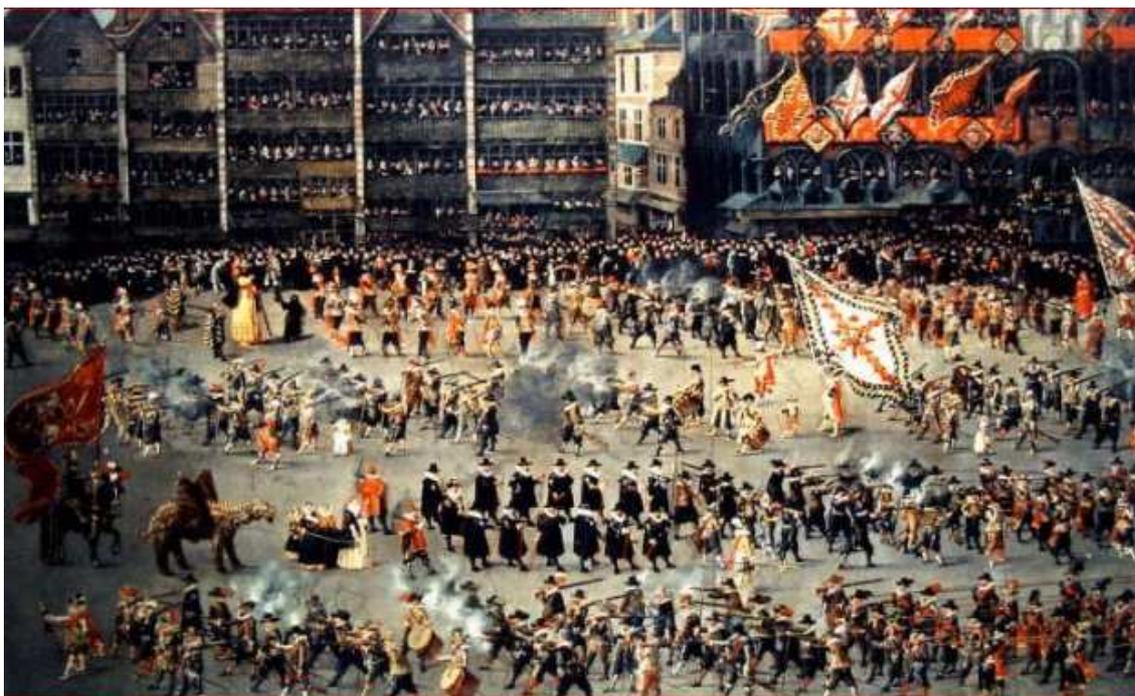
Fig. 11 – Denis Van Alsloot, *The Feast of the Ommegang on the Grand'Place* (detail), 1616 (© Royal Museum of Fine Arts, Brussels). In the left upper part of the picture, we can see some terraced houses with wood façades separated by sidewalls made of brick and stone

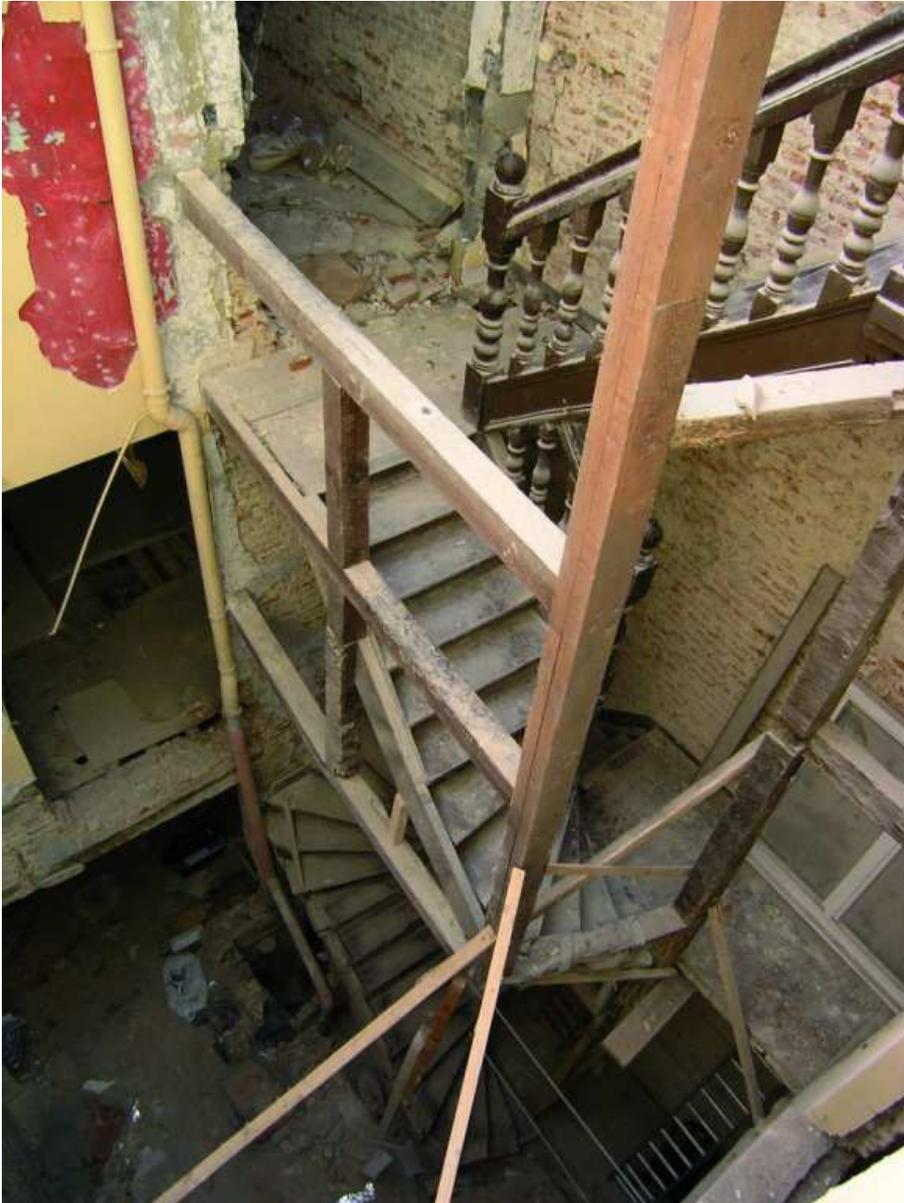
Fig. 12 – Rue de la Violette. Picture of the outside staircase connecting the front and the back house, dated around 1700 (© Royal Museum of Art and History, Brussels)
