Photographic rectification of the graphic documentation of historical and archaeological heritage:

The case of the southern facade of the *Praetorium* tower in Tarragona (Tarraco, Hispania Citerior).

Maria Serena VINCI¹ | Josep Maria MACIAS¹ | Miquel ORELLANA² | Imma TEIXELL³

Proceedings of the 17th International Conference on Cultural Heritage and New Technologies 2012 (CHNT 17, 2012)

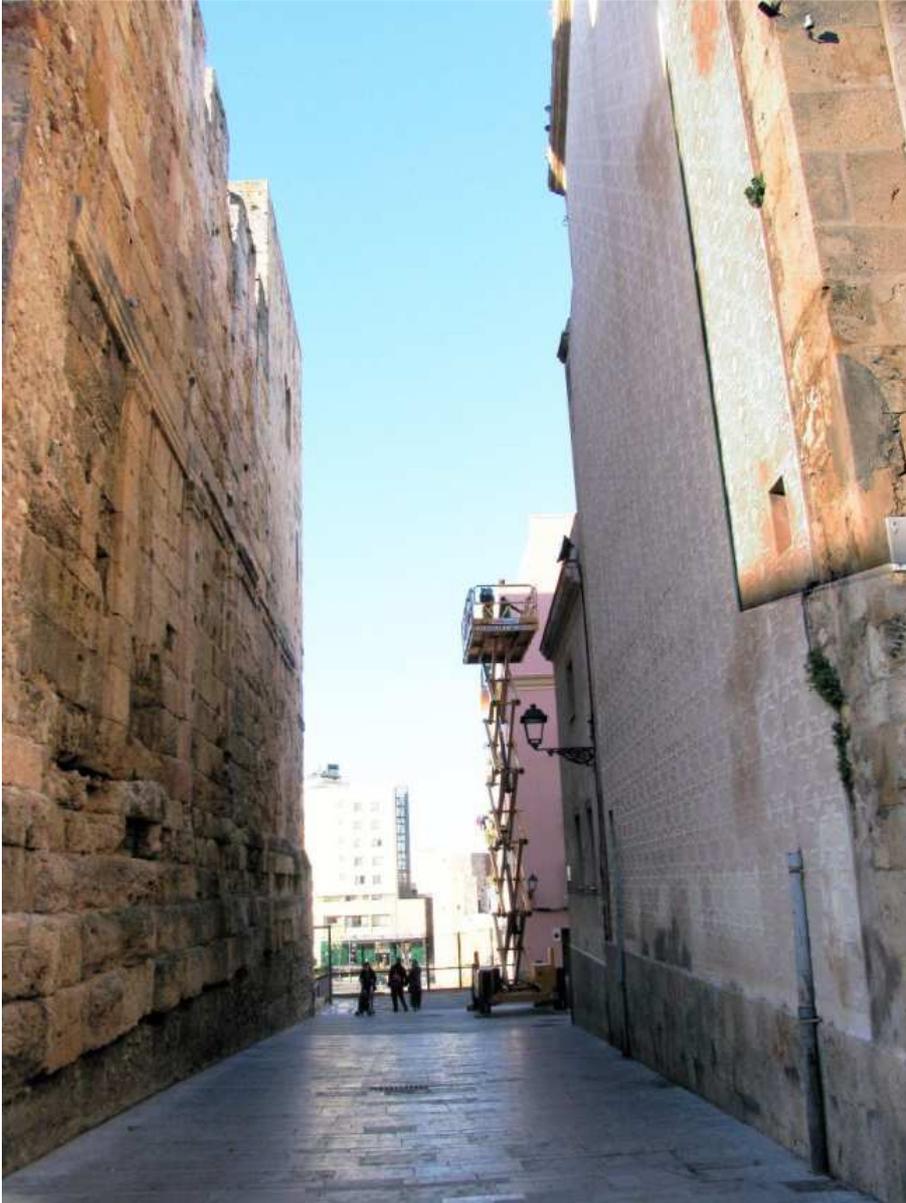
Fig. 5 – The street adjacent to the façade with the pilasters (Copyright: J. Maria Macias)

The building, which is in the square known as the Plaça del Rei, currently houses a branch of the Tarragona Museum of History. The main difficulty we had was the size of the wall facing (the height of the façade is about 23 m) combined with a shallow depth of field (Fig. 5). This meant that a large number of photos had to be taken to document the entire structure. The use of photogrammetry would have required double the number of frames for a successful solution (a pair of photos for each surface to be rectified); in this case, considering our purposes, it was more convenient to apply photographic rectification with control points and to process them using PhoToPlan. Due to the spatial situation, the photos were taken from different places: the lower part of the wall facing was photographed from the street and for the rest of the structure the photos were taken from an elevating platform (Fig. 6); this equipment allowed us to achieve a sequence of images and also to make a diagnostic analysis of the degradation of the stone. Altogether of 25 photos were taken with 6 topographic control points for each frame (bullseyes were not used for the topographic points; rather they were identified directly on the structure). As aforementioned, the surface to be rectified must have the same plane. In agreement with it, lesenes were considered as distinct elements during the rectification process. Afterwards, they were merged with the façade to form a unique mosaic-photo. We also placed a total station in different locations: on the street, just in front of the structure (for matching the control points

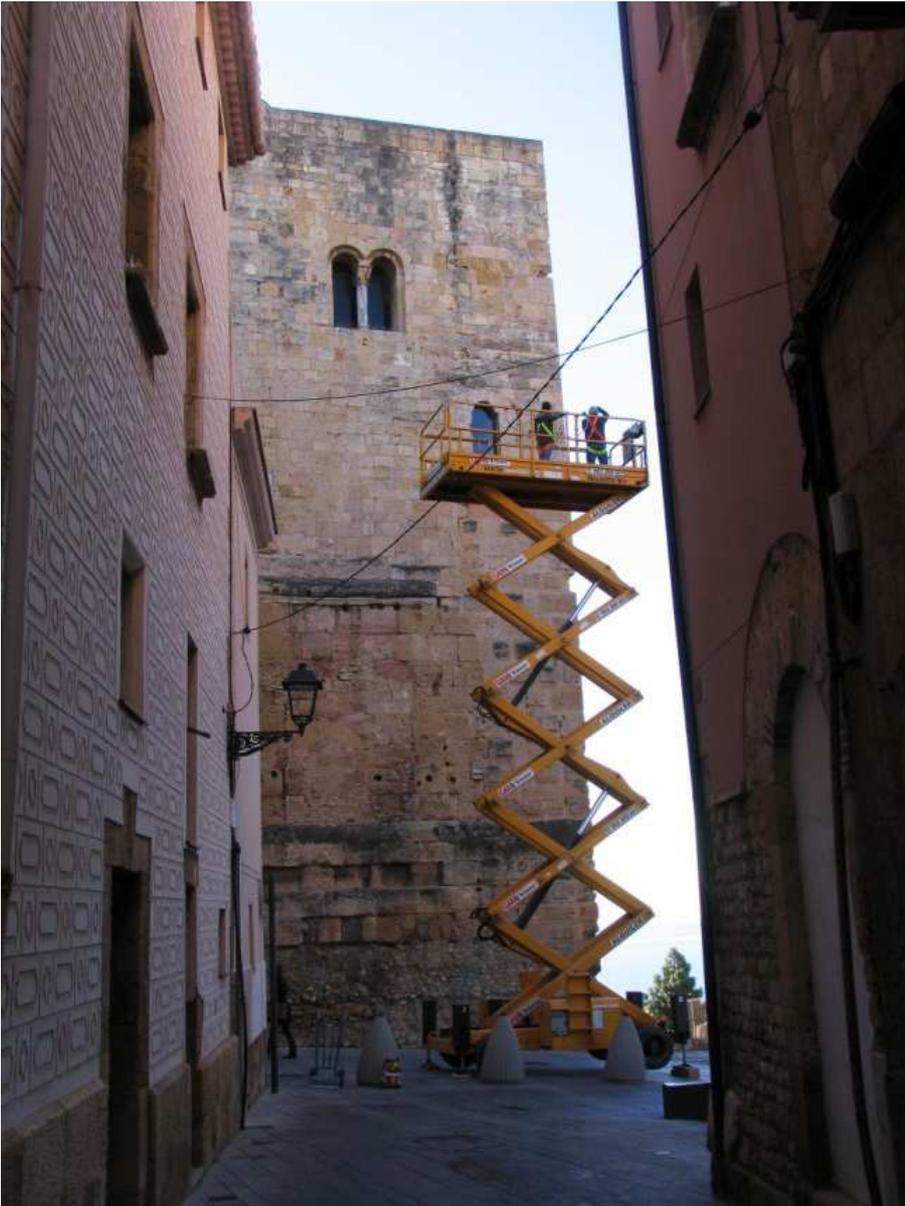
Fig. 6 – The lifting platform during the documentation process (Copyright: J. Maria Macias)

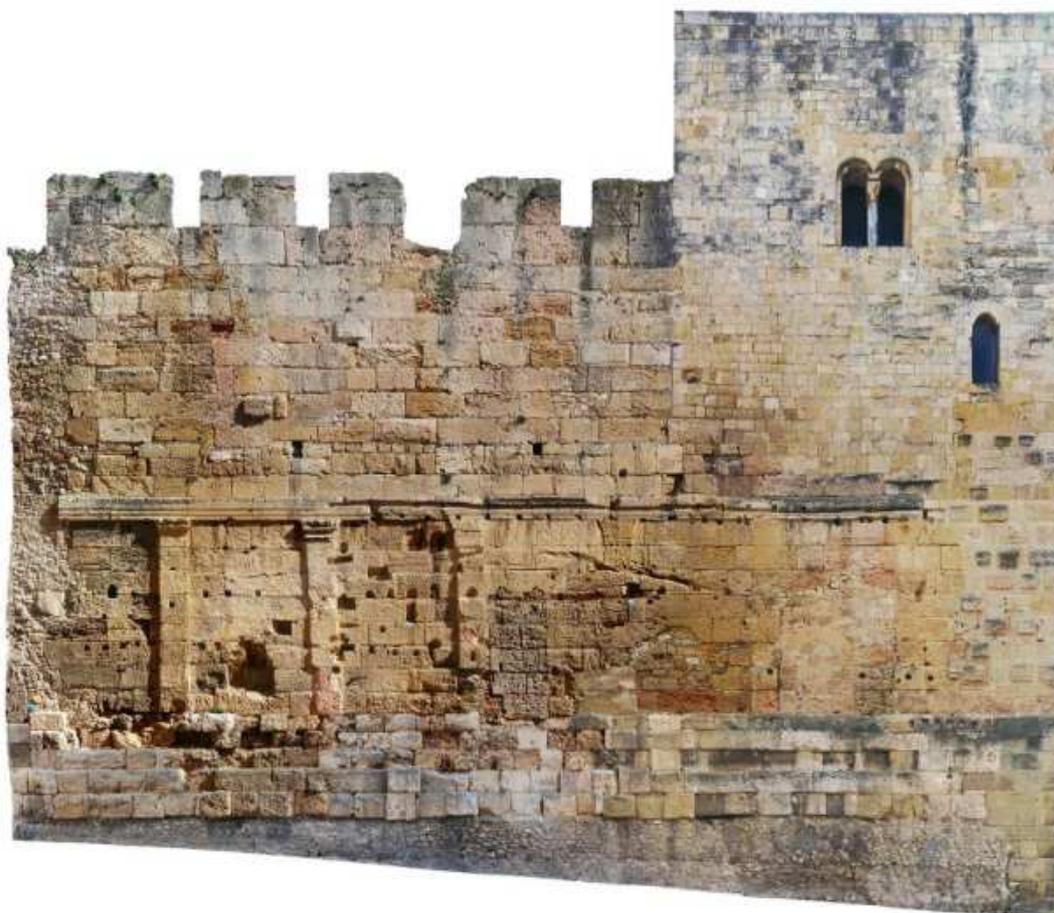
Fig. 7 – The orthophoto resulting from the process (Copyright: M. Serena Vinci)

The main result achieved with the application of photographic rectification was a scaled image that allowed different studies to be carried out (Fig. 7).

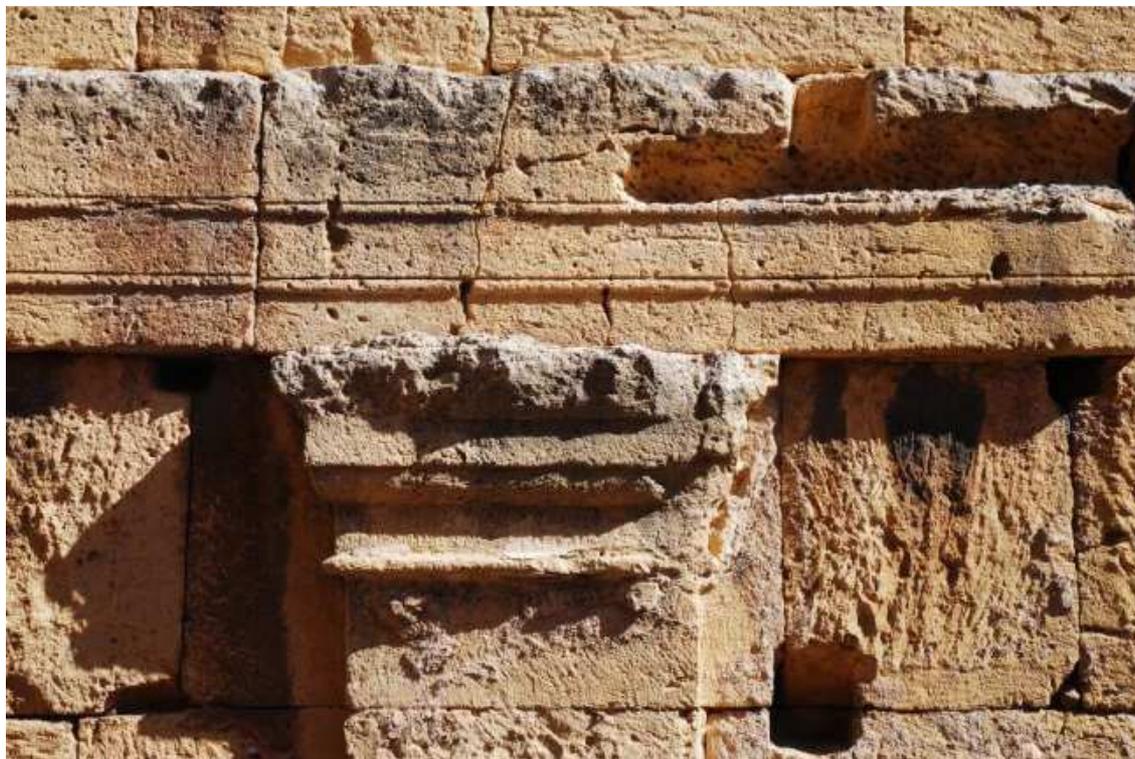
Fig. 9 – Part of the Tuscan capital (Copyright: M. Serena Vinci)

We analysed how the building materials were prepared, paying particular attention to the study of the working tools used. The Tarraco Provincial Forum was built almost entirely of limestone (the limestone used in Tarragona is called “Médol” and comes from quarries located 7 km from the city; GUTIERREZ 2009). The “softer” texture of this stone means that the tool marks have been better preserved; to classify them we needed to identify their shape, orientation and size (BESSAC 1986). The first step of the data acquisition and formal analysis of the structure was carried out in the field, although the integration of the visual analysis and the scaled image allowed us, above all, to measure the elements that were difficult to access. Moreover, the façade of the eastern wall of the Representational Square has interesting archaeological aspects, as it was

decorated with pilasters and Tuscan order capitals that were carved with precision in the ashlar of the wall (Fig. 9).
